Hester

Marsh

Restoration:

Annual

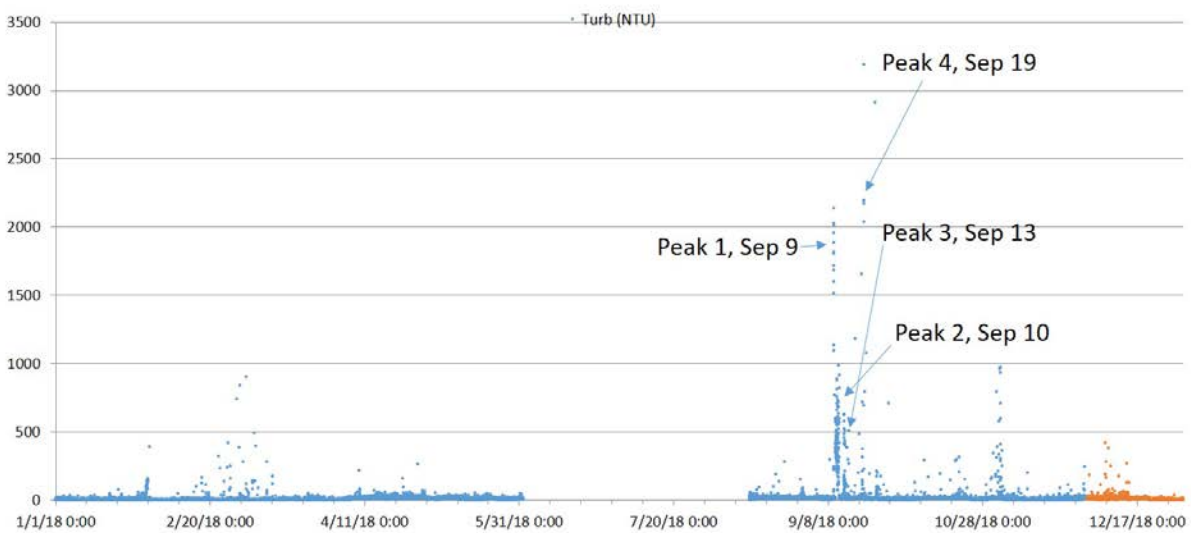
Fig. 4 Hester water quality 2018 - turbidity

Peak 4, observed from 9/19 at 2am to 4am occurred on an incoming tide and is thus not likely to be caused by waters from the project area, as the tide was coming in from the main channel.

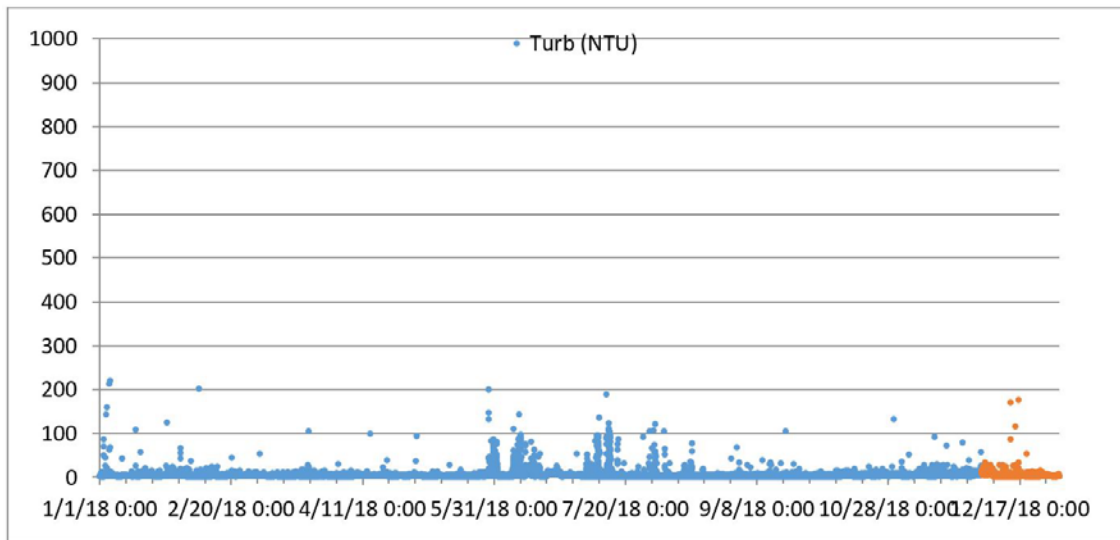
Fig. 5 Vierra water quality 2018 - turbidity

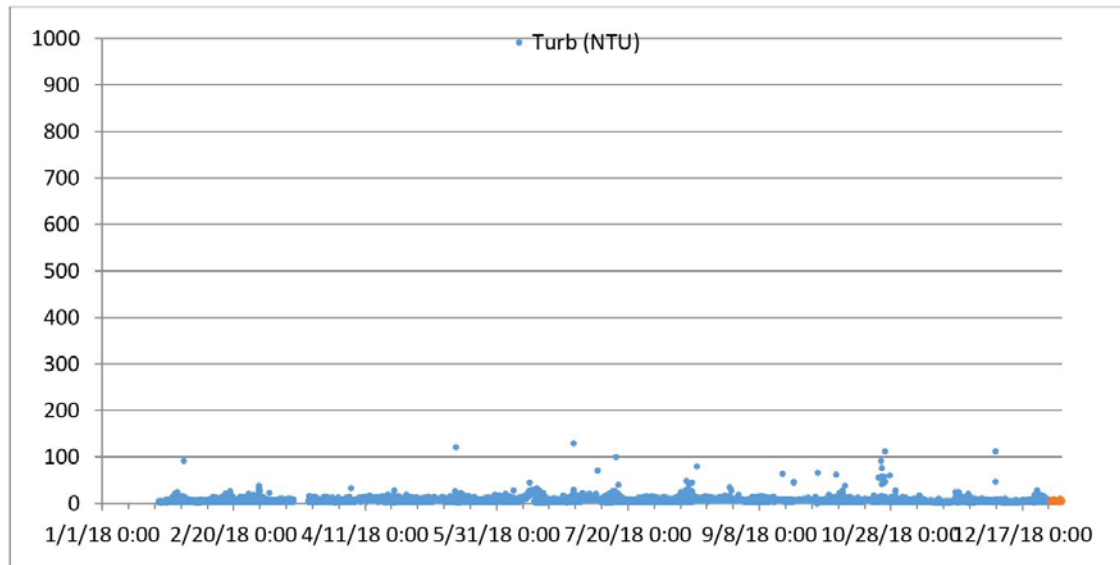
Fig. 6 South Marsh water quality 2018 - turbidity

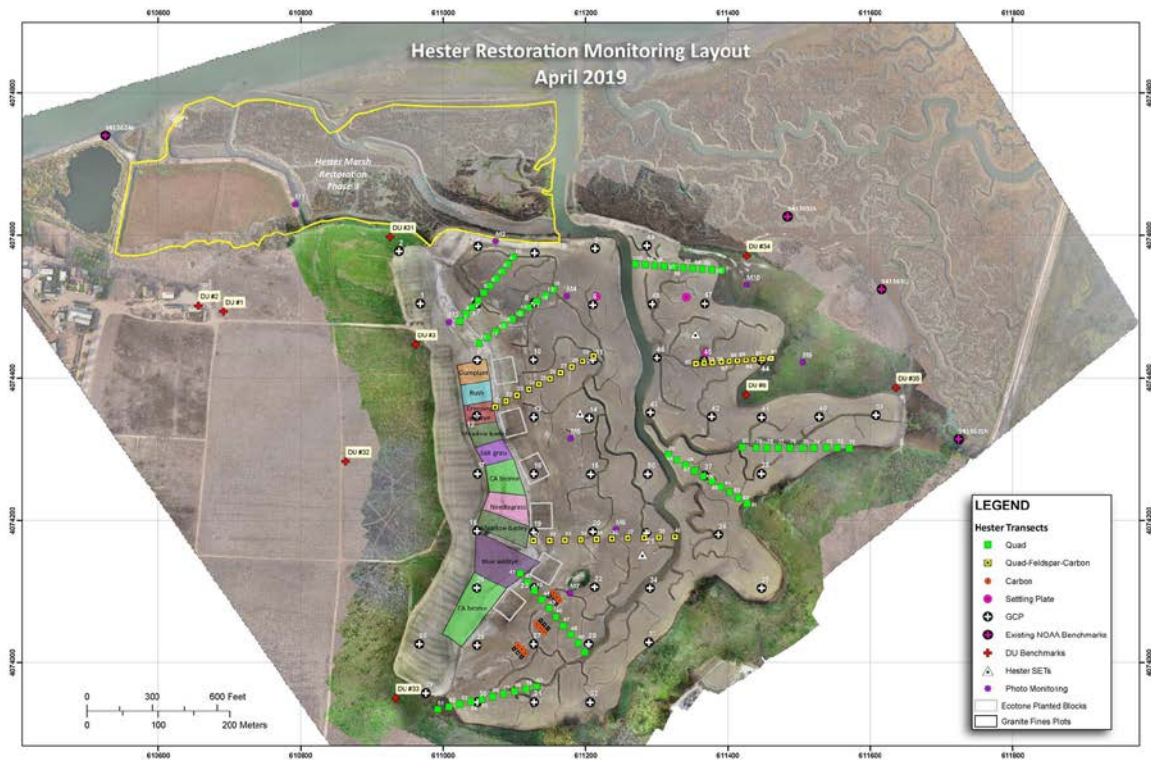
Fig. 1. Monitoring and transect map of project area.

All sections of the methods and results will refer to locations of sample collection and transects within the project area ().

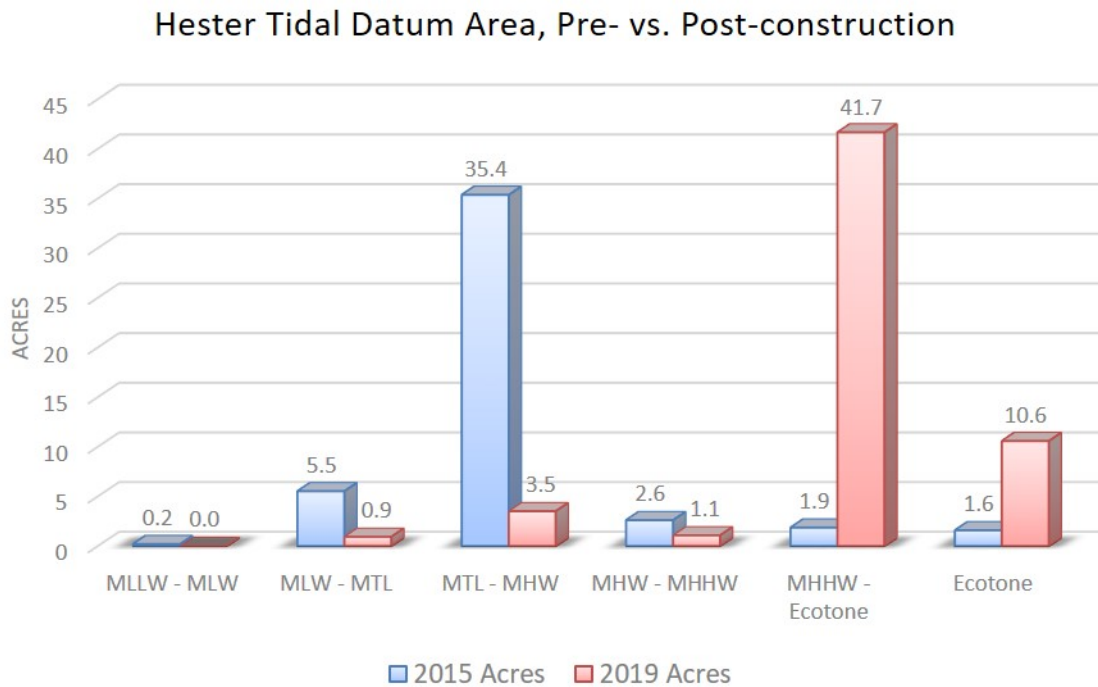
Fig. 2. Acreage of elevations before and after construction/restoration

Approximately 230,000 cubic yards (175,850 m³) of sediment have been added to an average elevation of 6.4 feet (1.95 m) NAVD, as of 8/15/2018. Fig. 2 below shows the area (acres) of tidal datums (within the construction zone only) at Hester Marsh change from before construction, relative to after construction (Fig. 2). In all, nearly 50 acres (20 ha) of new high marsh (i.e. includes above MHHW and ecotone) was created.

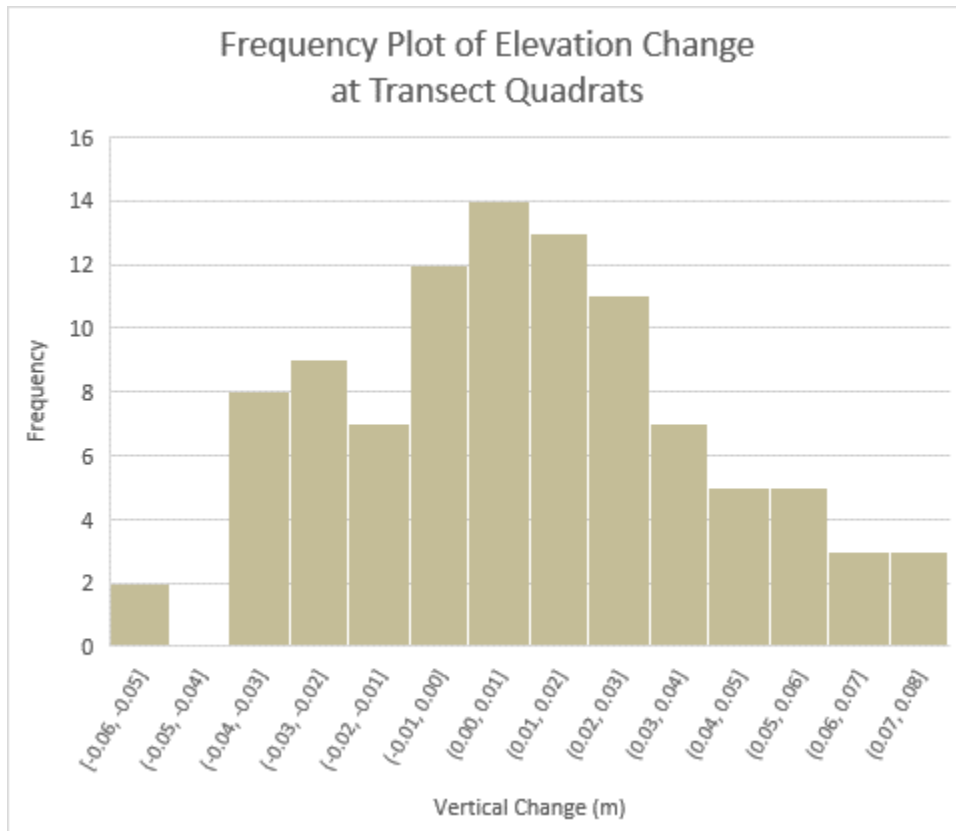
Fig. 3 Elevation change at 100 quadrats distributed in the project area over the 5 months post construction.

A comparison of surveyed elevations collected at each corner of the transect quadrats (100 total) between August 29, 2018 and January 29, 2019 reveals minimal vertical change throughout the marsh plain. The frequency plot below (Fig. 3) shows the majority of surveyed elevations fell within 1.2 inches (3 cm (+/-)) of the original surveyed point. Taken together, the mean difference of all surveyed points was only 0.47 inches (1.2 cm). At this time (March 2019), measurements of accretion relative to feldspar marker horizons have not yet been recorded.

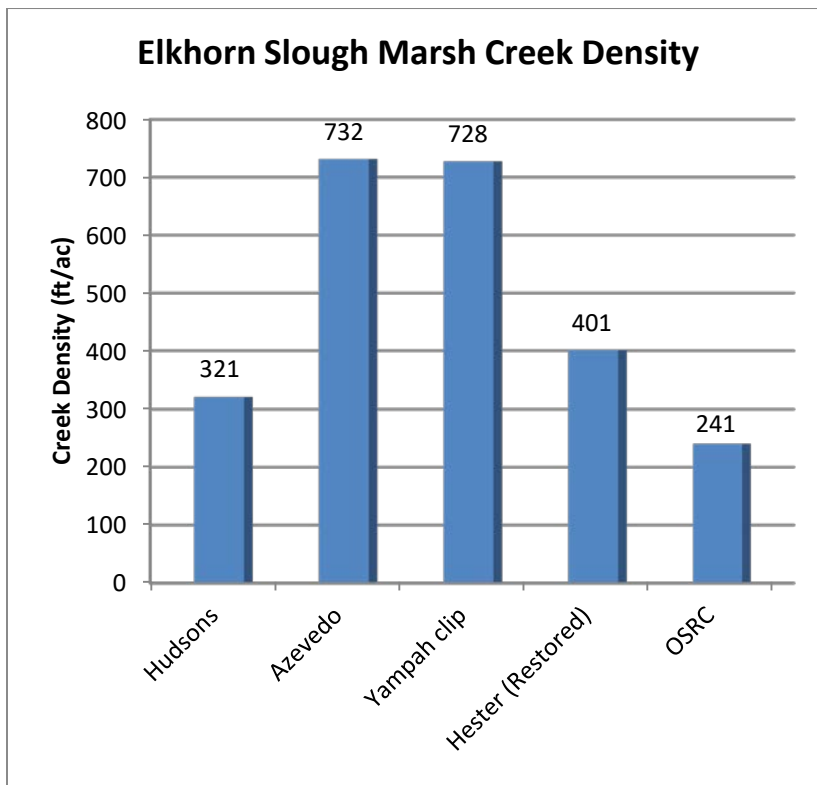
Fig. 4 Comparison of different creek densities in Elkhorn Slough marshes.

The post-construction creek density at Hester Marsh (including the main channel) is 401 ft./ac. (302 m/ha), in the range of other healthy marshes at Elkhorn Slough (Fig. 4)

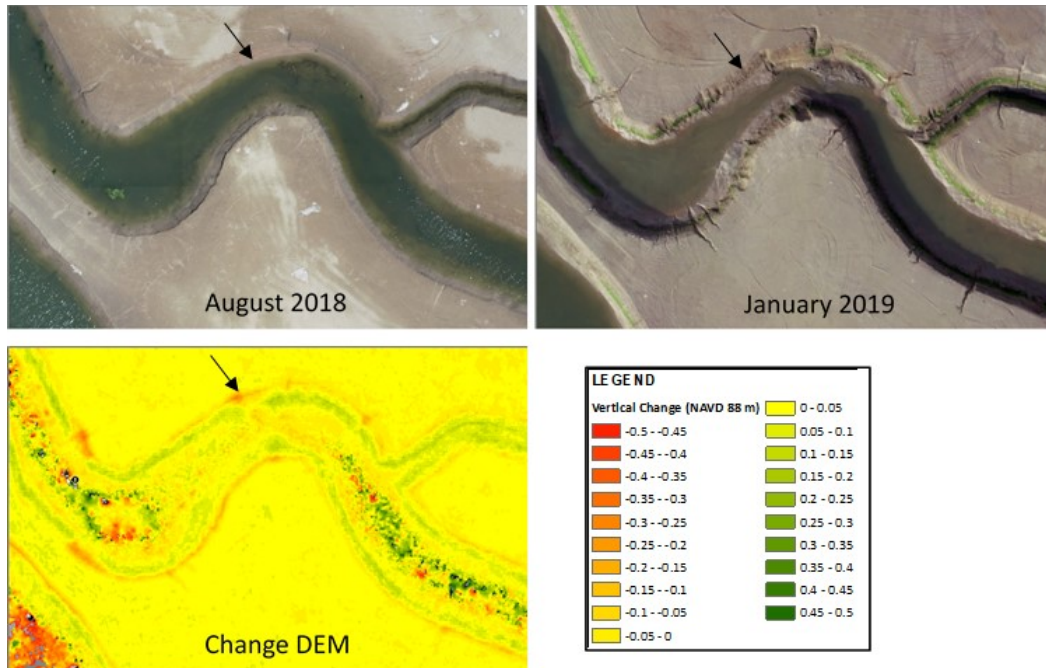
Fig. 5 Creek edge which has experienced localized erosion and retreat

Post-construction UAV DEM comparisons of Hester Marsh between August 29, 2018 and January 29, 2019, indicate only minor erosion along the creeks (Fig. 5). A summary of mean elevation change for areas that are within 1 m of the creek-bank edge is within the detection limit (i.e. error tolerance of +/- 2 inches [5 cm]) for confidently assessing change from UAV DEM comparisons. However, there are some specific areas where we can confidently identify change. Fig. 5 below shows an example of a creek edge that has experienced localized erosion and retreat (note that DEM elevations in the channels are incorrect due to the presence of water). The creek bank edge is possibly the most dynamic feature on the newly restored marsh landscape, experiencing both erosion and deposition with every tidal cycle. Attempting to quantify the change, however, is complicated by the fact that any erosion of material from above may be re-deposited on the bank below. Nonetheless, our UAV DEM comparisons are useful in identifying specific examples of changes in creek morphology.

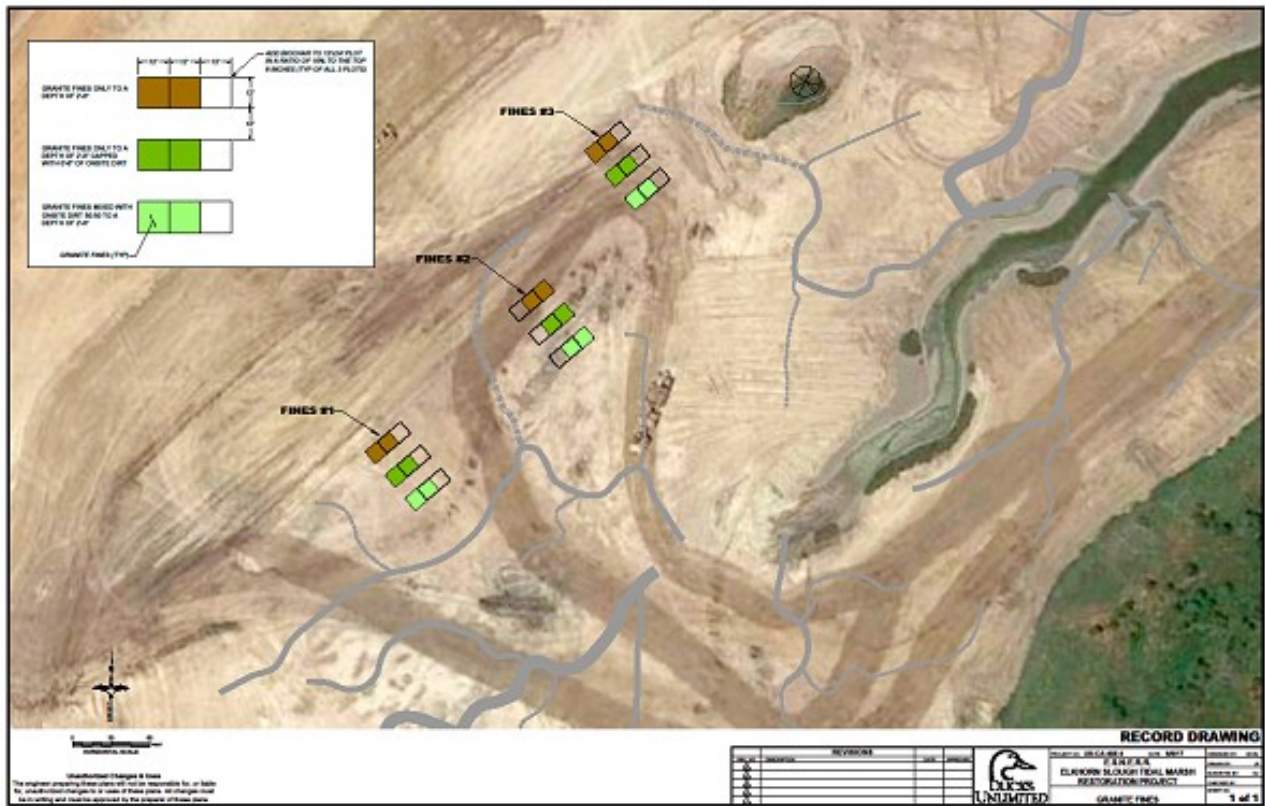
Fig. 8 Experimental design of granite fines and biochar use for restoration. Each replicate consists of three elevations each with three 12 x 12 ft squares at each elevation. One square was biochar only, one square was granite fines, and one square was both biochar and granite fines.

Each test plot was 12 x 12 ft. (3.66 x 3.66 m) and 2 ft. (60 cm) deep. Three rows of test plots were established, and each row was replicated three times, for a total of 27 12 x 12 ft. plots (Fig. 8). Row 1 had granite fines only, with no soil cap. Row 2 had granite fines only, capped with 6" of on-site soil. Row 3 had a 50:50 mixture of granite fines and on-site soil. To determine whether soil amendment would enhance marsh plant growth in granite fines and/or the nutrient poor soils excavated from the hillside we added biochar to the middle and one end 12 x 12 ft square at approximately 10 % biochar by volume (see section 1.3e). See Fig. 8 for map of experiment.

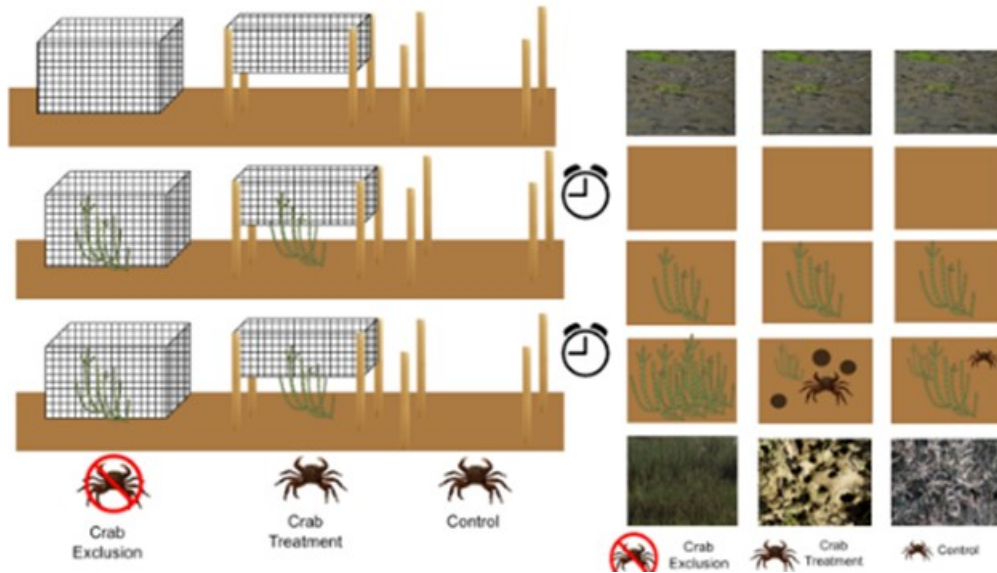
Fig. 9 Crab exclusion experimental design

3. Control: uncaged plots will be demarcated by four fiberglass poles indicated the perimeter of the plot area. Control plots will be the same size as experimental plots (listed above as 1 and 2). A narrow trench will be made around the plot perimeter.

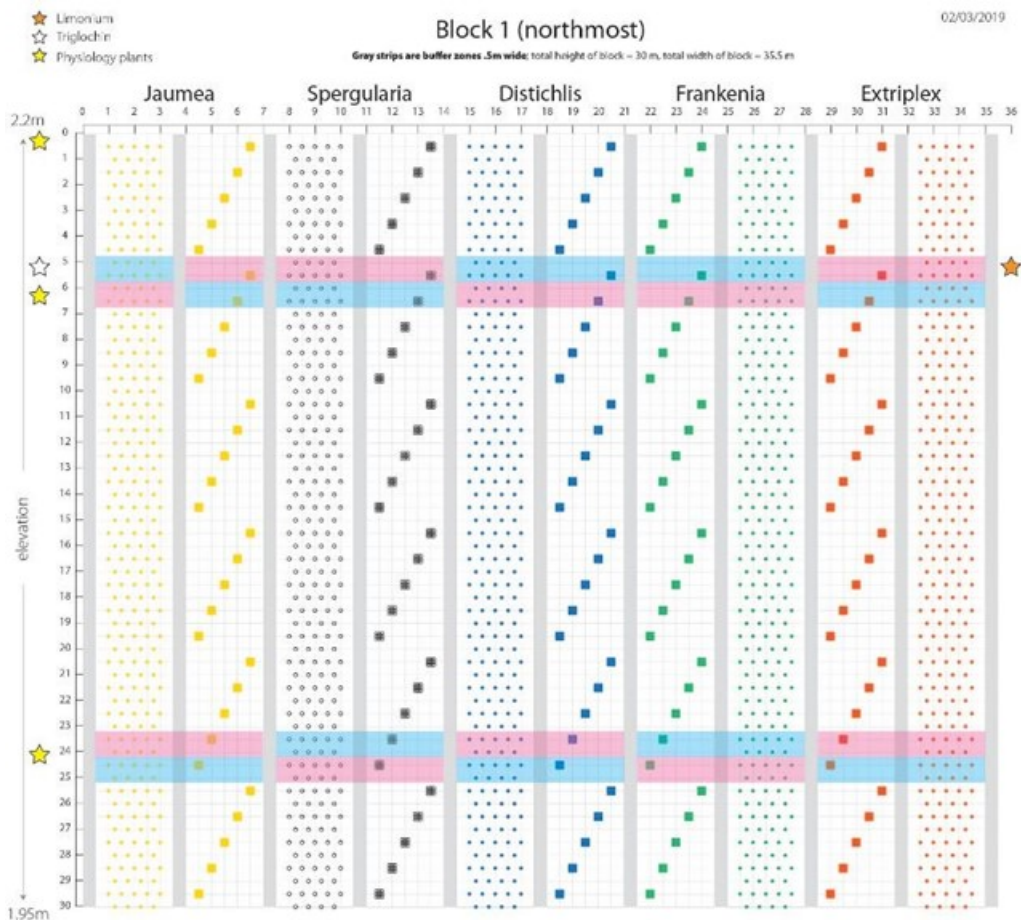
Fig. 12 Layout of plant patterns inside planted blocks.

- The walkways between columns are designated to walk on for staging planting, monitoring, etc. They are shown in gray in Fig. 12.

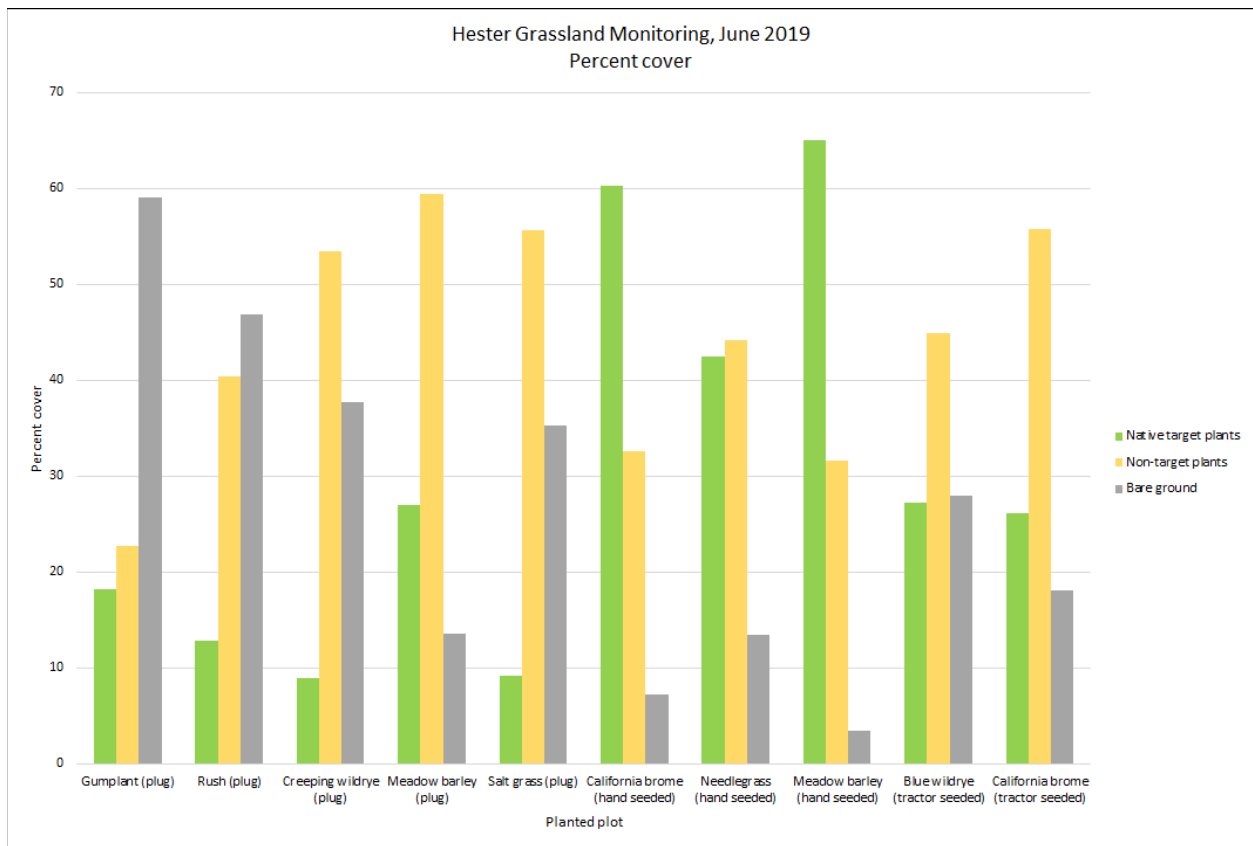
Fig 14b. Percent cover of plants in grassland restoration area, June 2019.

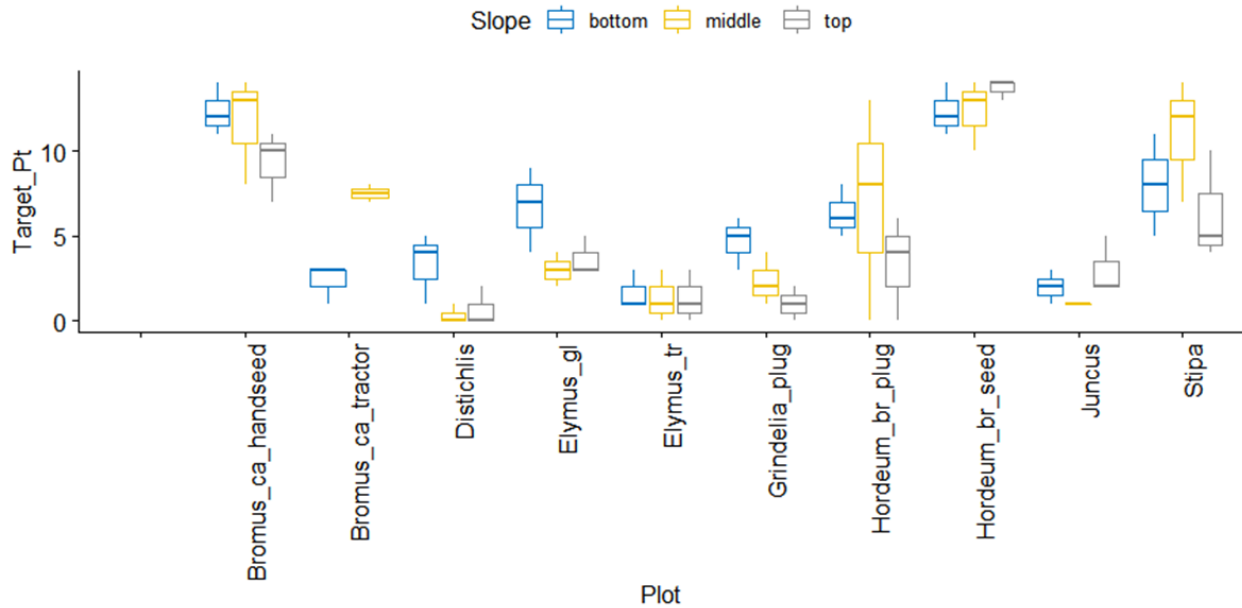
Fig 14 c. Percent cover of target plants by planting area and location on slope (bottom of hillside, middle, and top of slope).

When transect data were stratified by location on the hillside (Figure 14c), patterns were evident for three species. Salt grass (*Distichlis*), blue wildrye (*Elymus glaucus*), and gumplant (*Grindelia*) reached higher percent cover at the bottom of the slope.

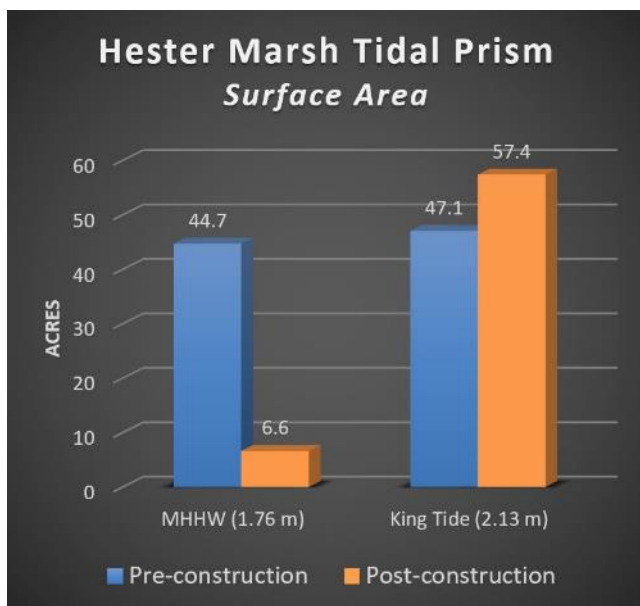
Fig. 16 The amount of wetted surface area during MHHW in the project area

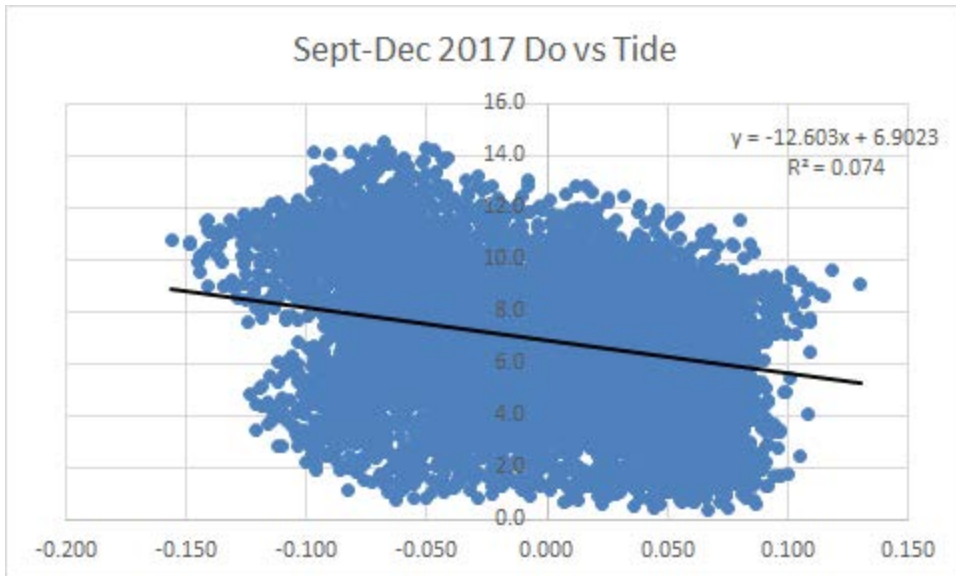
Fig. 17 2017 Dissolved oxygen concentration [mg/L] vs tidal direction. Positive x-axis values are incoming tides and negative x-axis values are outgoing tides. There is a slight correlation with elevated dissolved oxygen on the outgoing tides.

This pattern could be attributed to capping of old mudflat in the restoration area. After restoration, the water body in the project area was exposed to a smaller area of mudflat during each tide than before restoration. Pre-construction mudflat area at a mid-tide was higher and thus capable to drawing down more oxygen over night as opposed to post-construction where area of mudflat at a mid tide would be much less and thus have lower potential to draw down oxygen over night. Comparisons were made in the months from September to December of 2017 (pre-construction) and 2018 (post-construction) because tidal flow in the restoration area was obstructed from February 2018 to August of 2018.

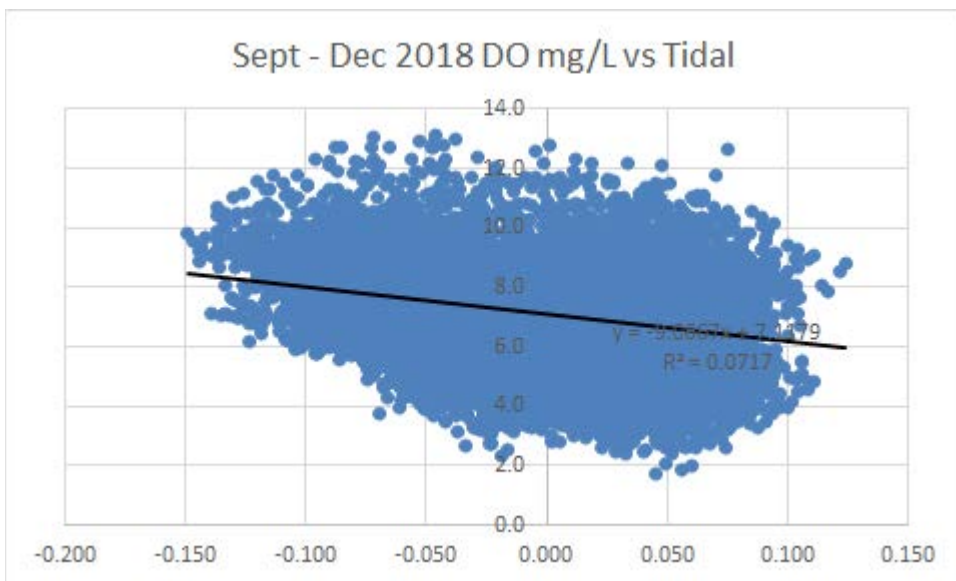
Fig. 18 2018 Dissolved oxygen concentration [mg/L] vs tidal direction. Positive x-axis values are incoming tides and negative x-axis values are outgoing tides.

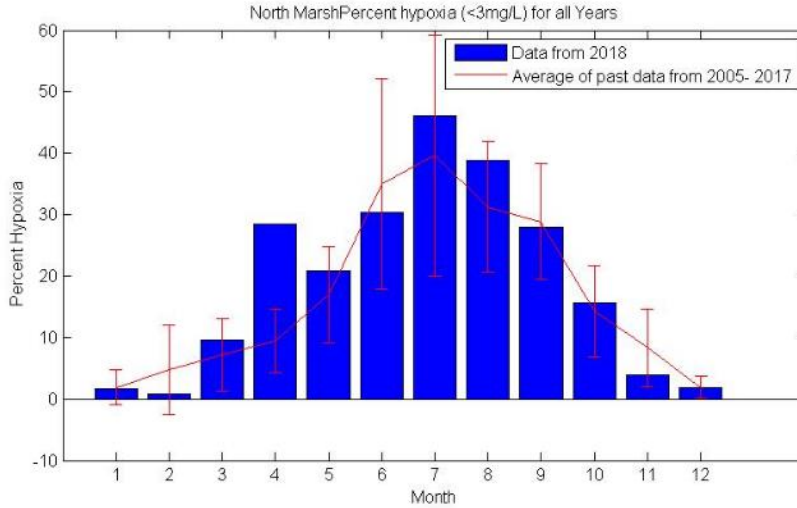
Fig. 21 Percent hypoxia during 2018 compared to historical data at control site, North Marsh (tidally restricted).

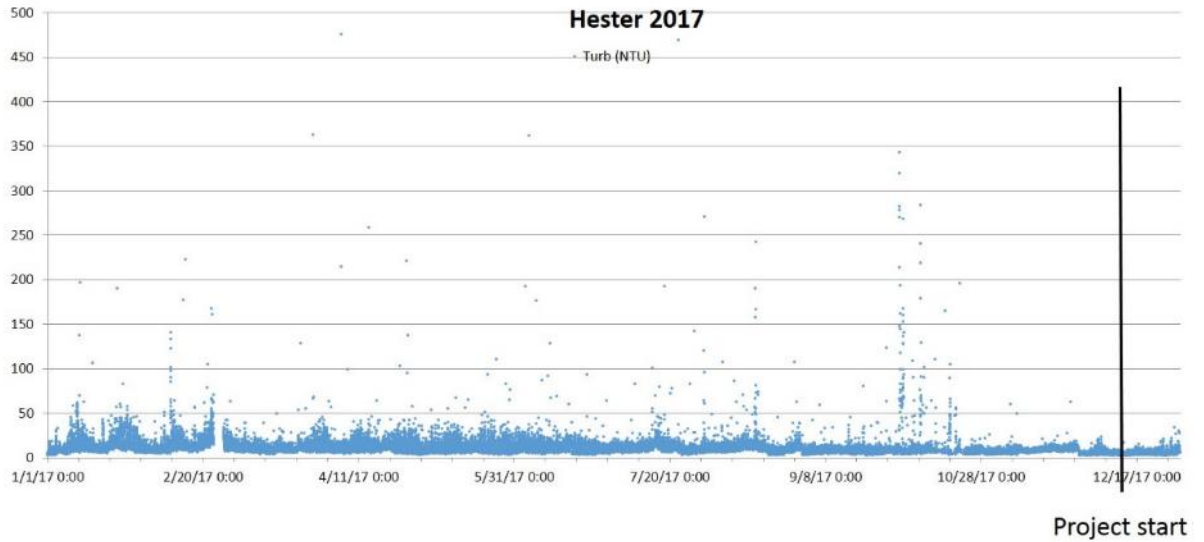
Fig. 22 Turbidity at Hester 1/1/17 to 12/31/17. Construction began 12/11/2017.

Before construction began (on 12/11/2017), turbidity at Hester was higher on average than at Vierra (Table 1). We did not see a spike in turbidity at the project site, or at the control site, immediately after construction began on 12/11/2017 (Fig. 22, Fig. 23)

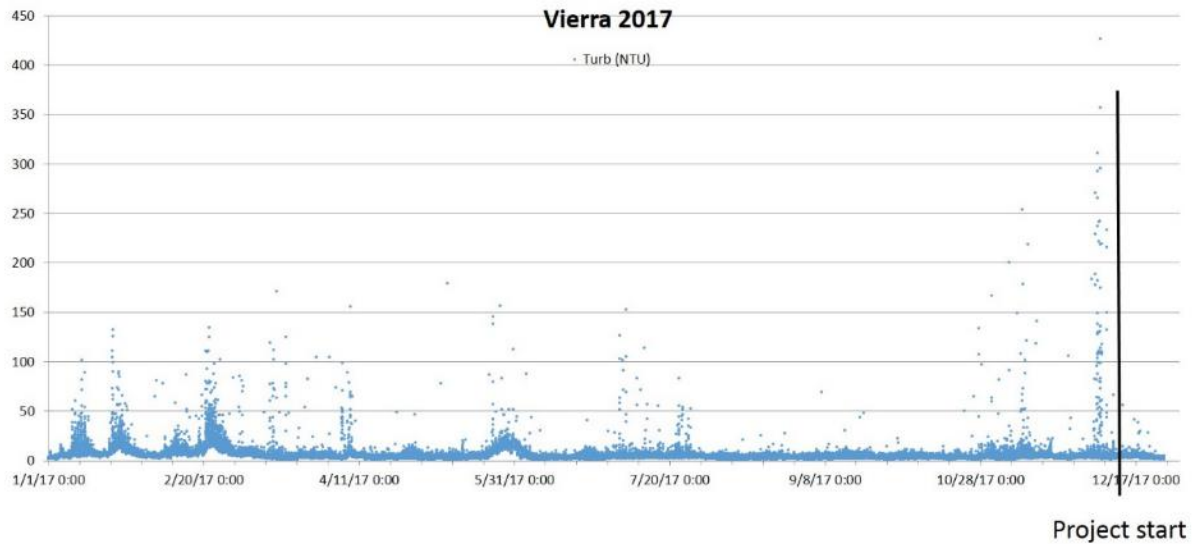
Fig. 23 Turbidity at Vierra 1/1/17 to 12/31/17. Construction began 12/11/2017

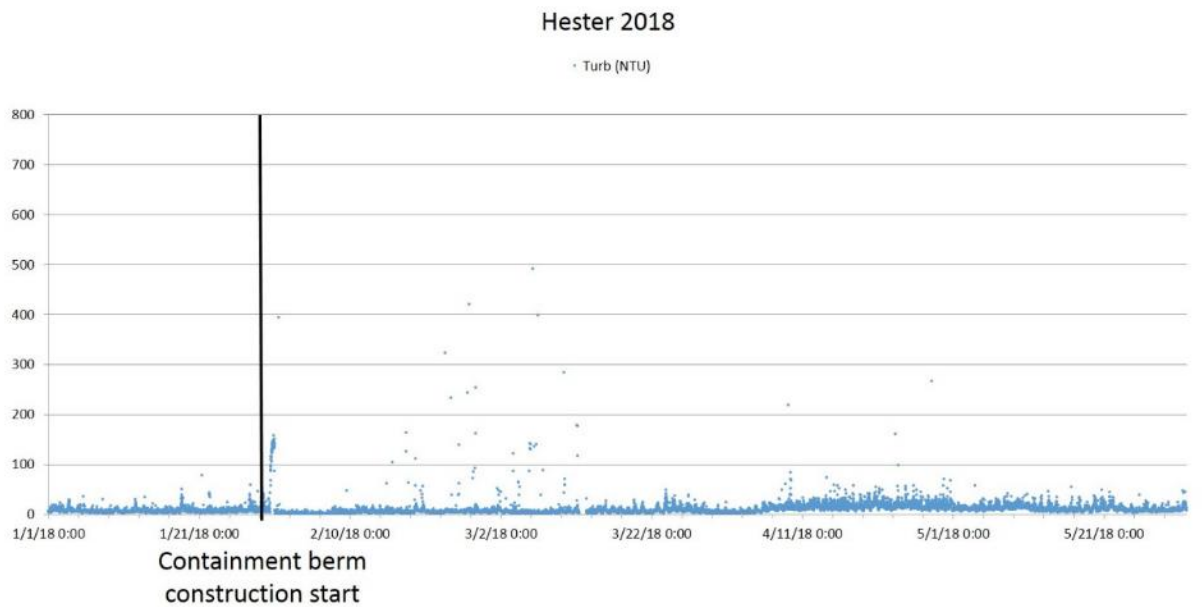
Fig. 24 Turbidity at Hester 1/1/2018 to 5/31/2018

At the end of January (1/29/2018), construction of a containment berm to block tidal action at the project was initiated. Although we did observe temporarily increased turbidity near the project site (Fig. 24) we did not detect this turbidity spike at the control site (Fig. 25), indicating that the effect of increased turbidity was localized, short ranged, and short lived.

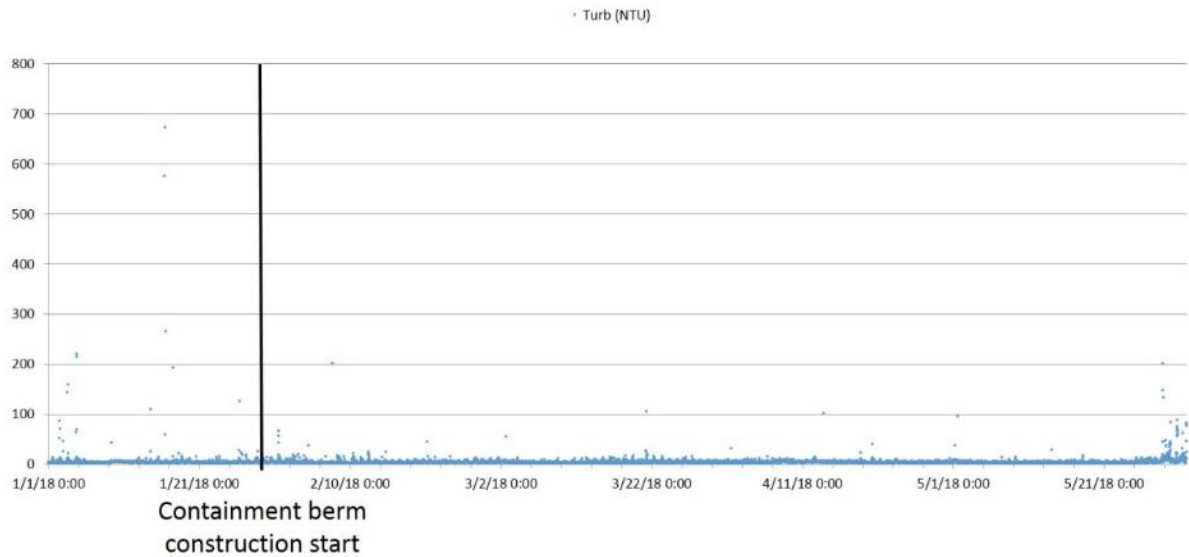
Fig. 25 Turbidity at Vierra 1/1/2018 to 5/31/2018

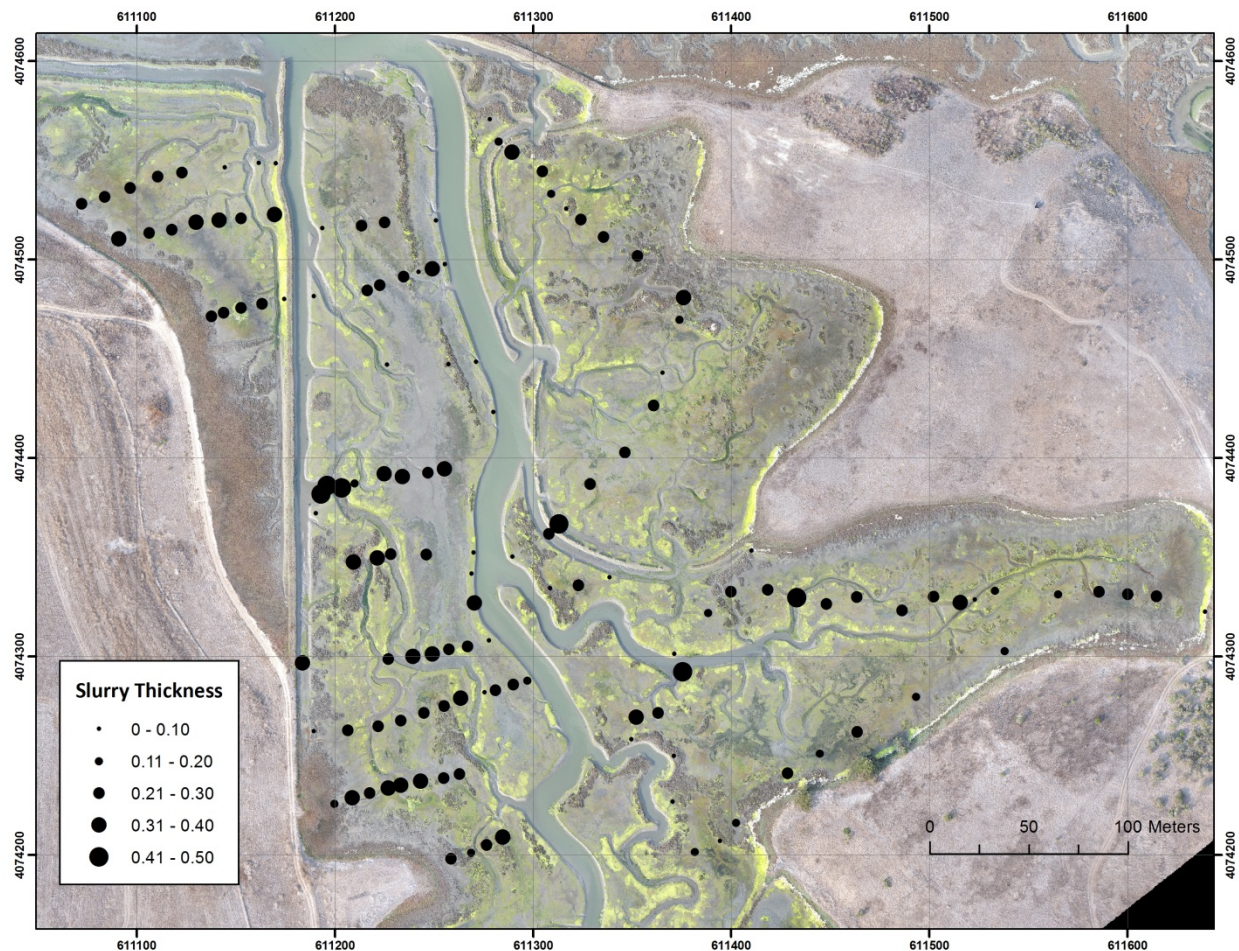
Figure 1 –Overview map of the MHM area and location of the 136 survey sites. The size of the circle at each site corresponds to the thickness of the 'slurry' layer

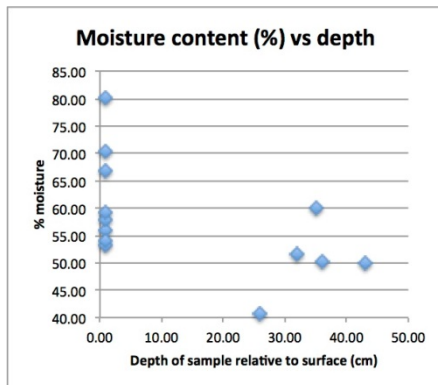
Figure 4 – The plot shows how the 'slurry' samples (0 cm) have higher moisture content than the samples from the 'plastic' layer (~25-45cm).

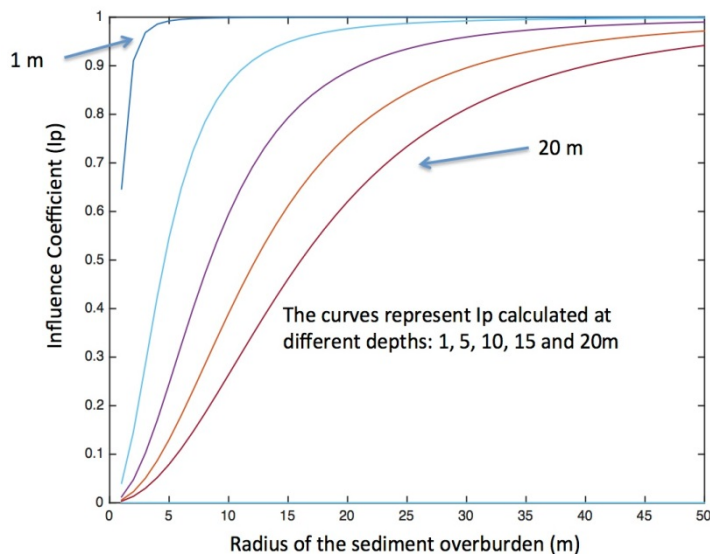
Figure 7 - The plot shows how the stress due to a sediment addition propagates with depth. The closer the Influence Coefficient I_p is to 1 the closer is the propagated stress to 100% of the load. The maximum thickness of compressible sediments predicted for Minhoto is about 10m.

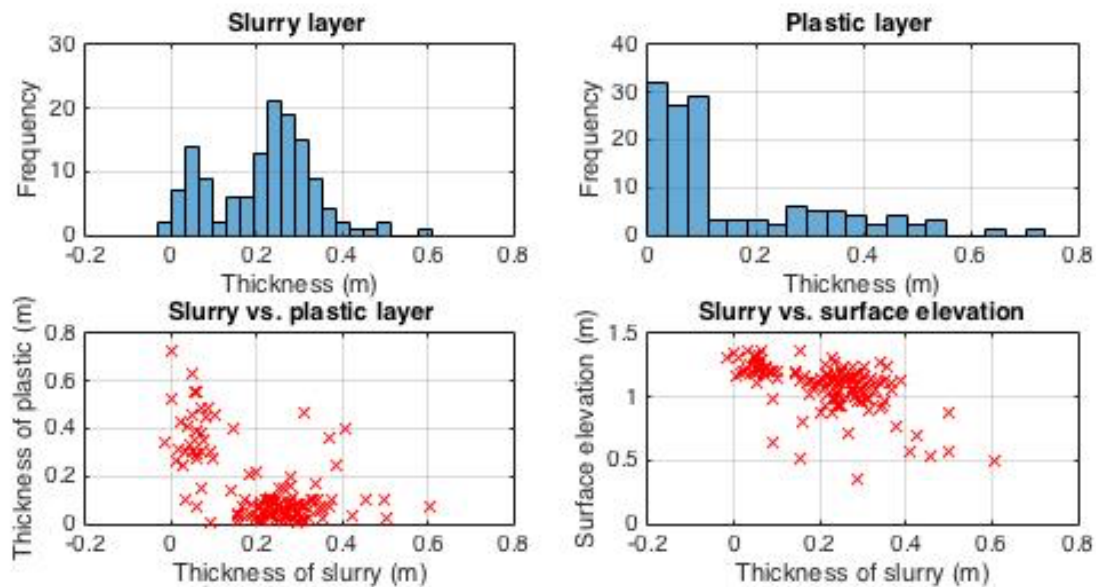
Figure 11 – Multipanel figure from the Matlab calculations: top row shows histograms of thickness distribution of the 'slurry' and 'plastic' layers. Middle row is similar to figures 7 and 8. Bottom row shows histograms of frequency distribution of the thickness of the overburden layer (left) and the total settlement after the overburden layer is applied (right).
