Hester

Marsh

Restoration:

Annual report summarizing the changes in conditions at Hester marsh after implementation of a major restoration project – marsh creation via sediment addition

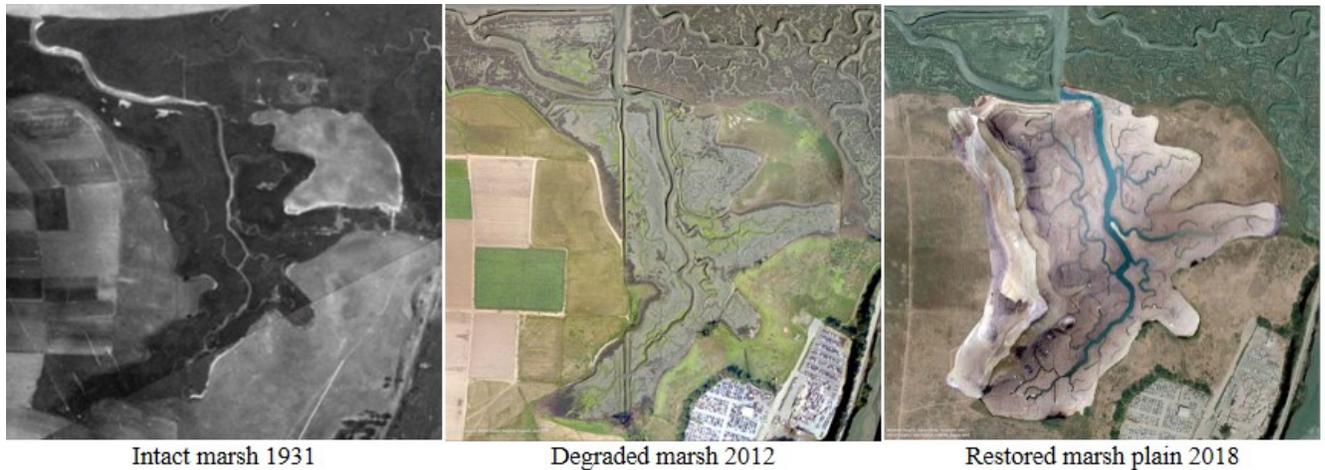
Fig. 3. Project Area with intact, degraded, and restored marsh plain over time.

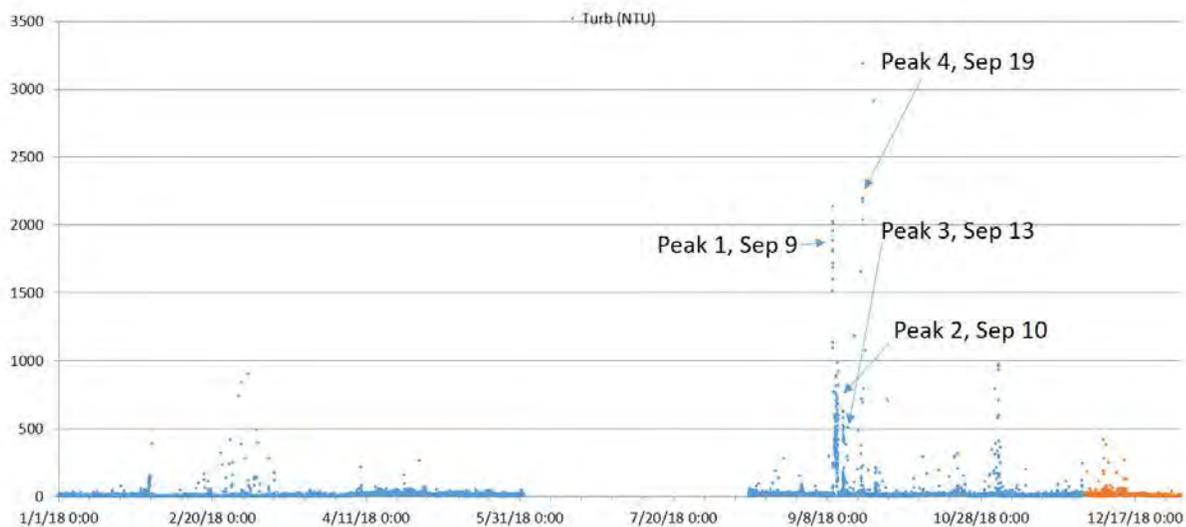
Peak 4, observed from 9/19 at 2am to 4am occurred on an incoming tide and is thus not likely to be caused by waters from the project area, as the tide was coming in from the main channel.

Fig. 4 Hester water quality 2018 - turbidity

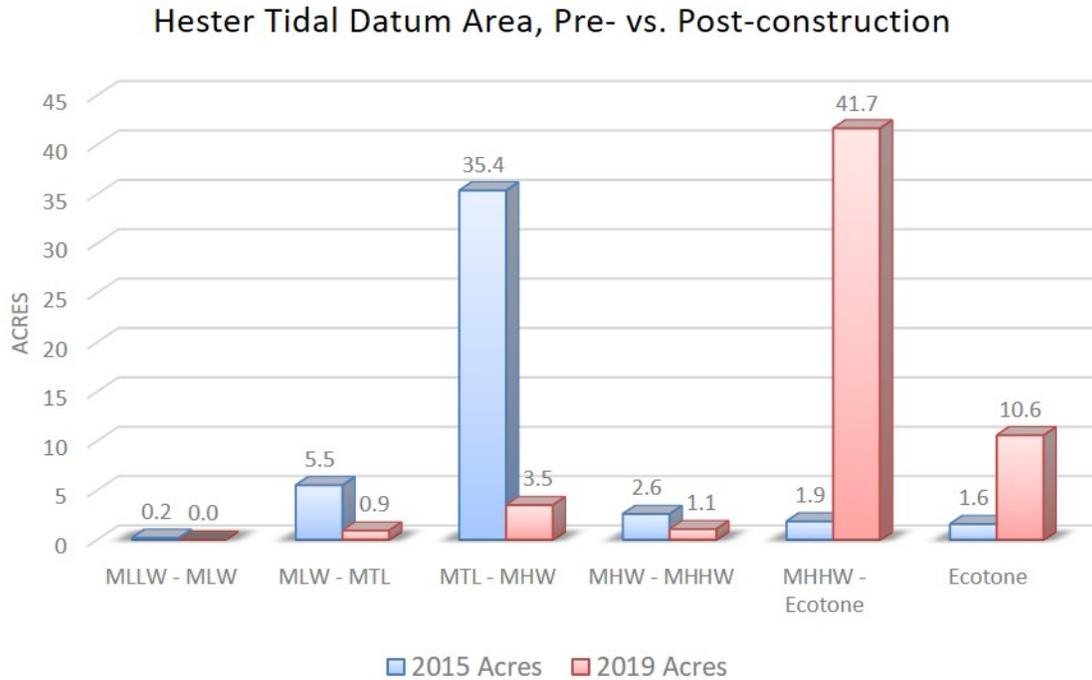
At Hester Phase I, approximately 230,000 cubic yards (175,850 m³) of sediment have been added to an average elevation of 6.4 feet (1.95 m) NAVD, as of 8/15/2018. Fig. 2 below shows the area (acres) of tidal datums (within the construction zone only) at Hester Marsh change from before construction, relative to after construction (Fig. 2). In all, nearly 50 acres (20 ha) of elevation that should support new high marsh (i.e. includes above MHHW and ecotone) was created.

Fig. 2. Acreage of elevations before and after construction/restoration at Hester Phase I.

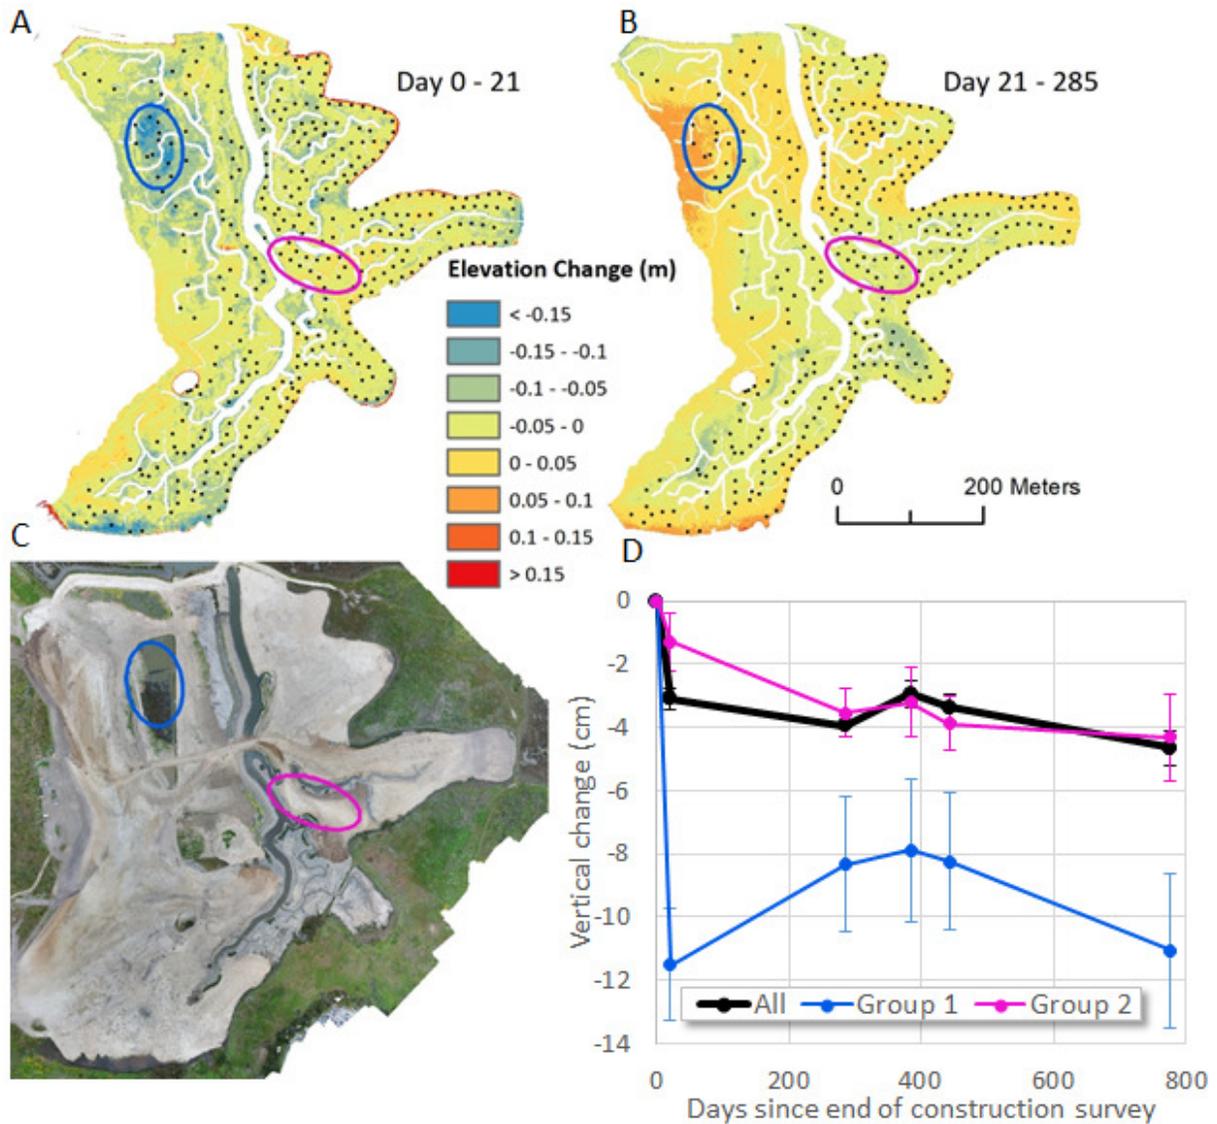
Analysis of UAV-generated DEMs at Phase I revealed some immediate loss of elevation, followed by a very gradual decline (Fig. 3). We compared over 300 points taken from an RTK immediately following construction with DEMs generated at five different time intervals following construction. In the marsh plain overall, there was a decrease of 1.7 inches (4.7 cm) between August 2018 to September 2020. Likewise repeat elevation surveys of the 100 quadrats along the 10 transects revealed only minor loss of elevation, about 1 inch between August 2018 and September 2020 on average. Length of the conduit pipe/erosion pins along the three focal transects changed much less than that, suggesting compaction occurred deeper than the 5-10 feet these pipes had been pounded into the marsh. Feldspar marker horizons along these three transects mostly disappeared; this appeared to be due to wind blowing the feldspar and not erosion. Where marker horizons were refound, a tiny layer of accretion had occurred. In 2020 we buried tiles to track accretion rates, replacing feldspar.

Fig. 3. Spatial and temporal patterns of elevation change at Hester Marsh. (A) DEM difference showing elevation change in the first 21 days following construction, assuming a consistent Day 0 elevation of 1.95 m. Black points show locations of the RTK survey completed at the end of construction in 2018. (B) Elevation change between Day 21 and Day 285. (C) UAV orthomosaic captured in May 2018 showing an area where excess water was contained during construction (blue oval) and where soil was compacted early on as part of a construction vehicle route (fuchsia oval). (D) Mean difference in original RTK-surveyed elevations and elevation values extracted from four post-construction DEMs at those surveyed positions. The black line represents elevation change at all RTK-surveyed positions, blue line represents the subset of locations within the blue oval in all maps, and fuchsia line represents the subset of locations within the fuchsia oval in all maps.

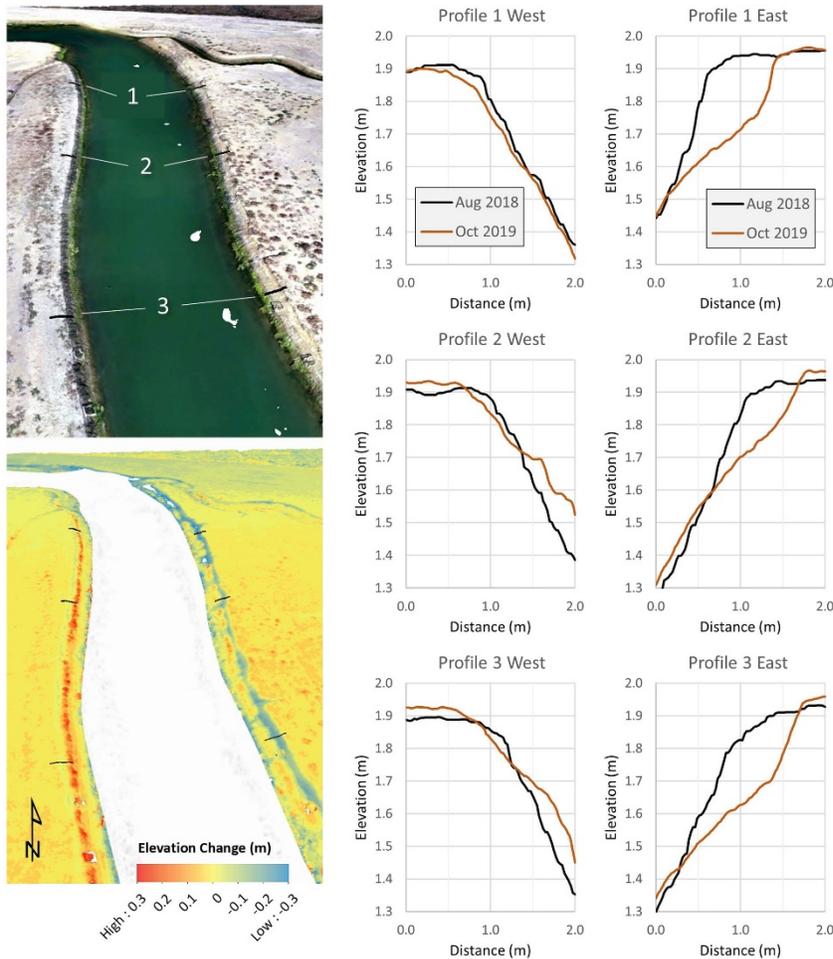
Fig. 4). Post-construction UAV digital elevation model (DEM) comparisons of Hester marsh over the first 12 months' post construction, indicate moderate erosion along the creeks (Appendix 4, Table 1). Total volume loss for areas that are within 3.3 ft. (1 m) of the creek-bank edge is 281.7 cu yd (215.4 m³) while mean elevation change is -0.6 in (-1.5 cm). Less erosion was observed on the firm channel edge (Appendix 4, Fig .5).

Fig. 5. A portion of the Hester Marsh main channel shown in (A) an October 2019 orthomosaic, and (B) a DEM difference between August 2018 and October 2019. The west bank of the channel was reinforced with mud excavated from the former wetland; the east bank had no reinforcement. (C) Vertical profiles extracted from UAV DEMs were used to evaluate erosion of the main channel banks between August 2018 and October 2019.

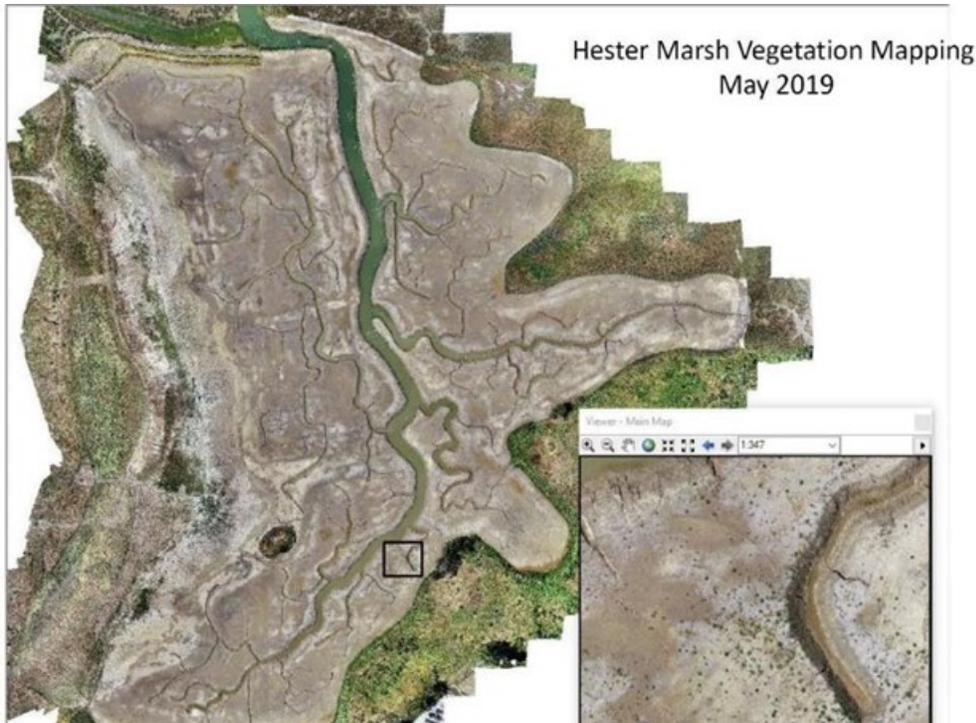
Vegetation has colonized Phase I. Most frequently encountered species are pickleweed and *Spergularia* sp. (Fig. 6)

Fig. 6 Green dots in insert are primarily pickleweed and *spergularia* sp.

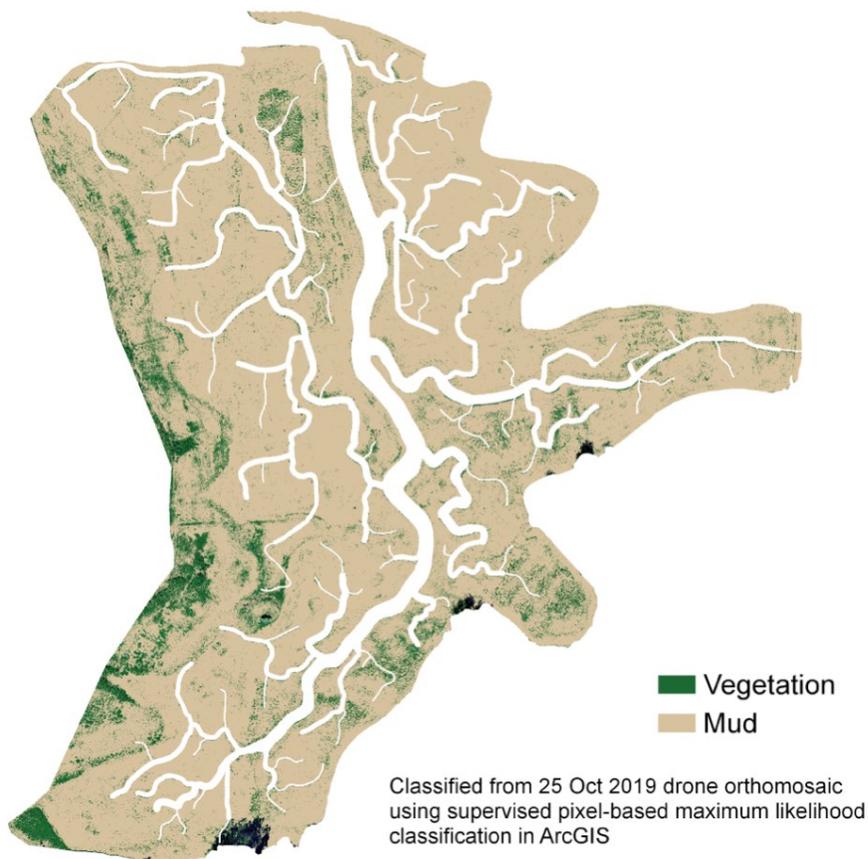
Preliminary image classification has been completed in ArcGIS Pro version 2.4.2 (ESRI 2018) using a supervised, pixel-based approach and maximum likelihood classifier (Fig. 7; overall accuracy approximately 94%). The classified image is used to evaluate factors associated with vegetation colonization. For example, we performed image classifications on imagery from both October 2019 and September 2020 and compared the results within a DEM reclassified to 5 cm bins between 1.65 and 2.00 m NAVD88. The results show most vegetation expansion has occurred within the 1.75 - 1.80 m range (Fig. 8). Overall, 7.6% of the marsh (3.59 ac) had recolonized by October 2019, increasing to 15.5% (7.25 ac) by September 2020. The classification results represent a conservative estimate of total marsh vegetation and may in fact be slightly lower than actual vegetation coverage. The vegetation coverage measured in the marsh transects was approximately two times higher than the vegetation coverage from the classification. For details on transect vegetation coverages, see section 1.3d Marsh transects.

Fig. 7 Classified image of Phase I based on remotely sensed imagery collected 25 October 2019.

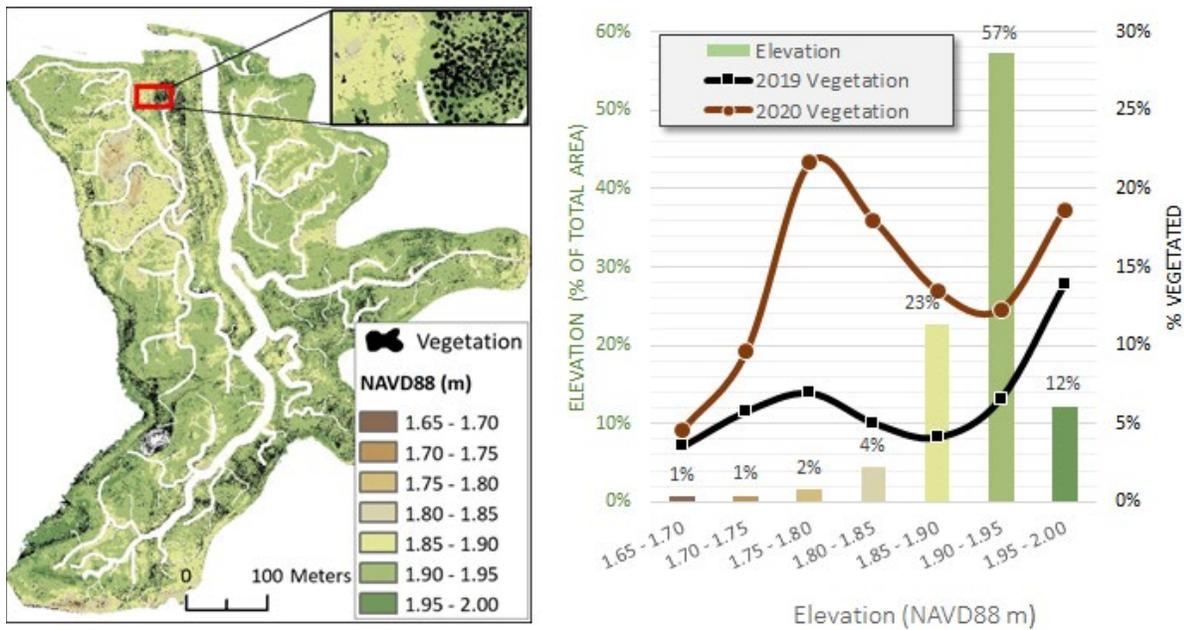
Fig. 8. Map of classified vegetation on top of an August 2018 DEM showing elevation in 5 cm increments (left). Percent of total area (histogram) and percent vegetated area (line) in each

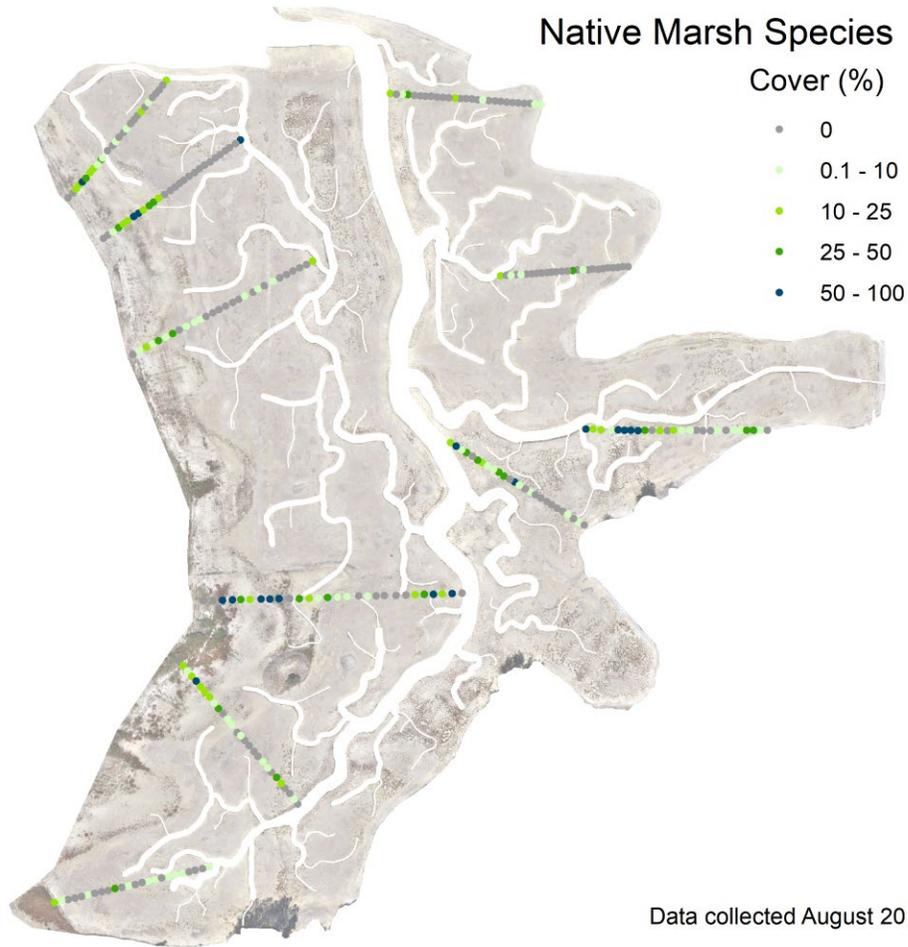
Fig. 11 Spatial variation in percent cover of native marsh species in August 2019 (99% of which was *S. pacifica* cover). Generally, high cover appears to be associated with higher-elevation areas and tidal creek edges.

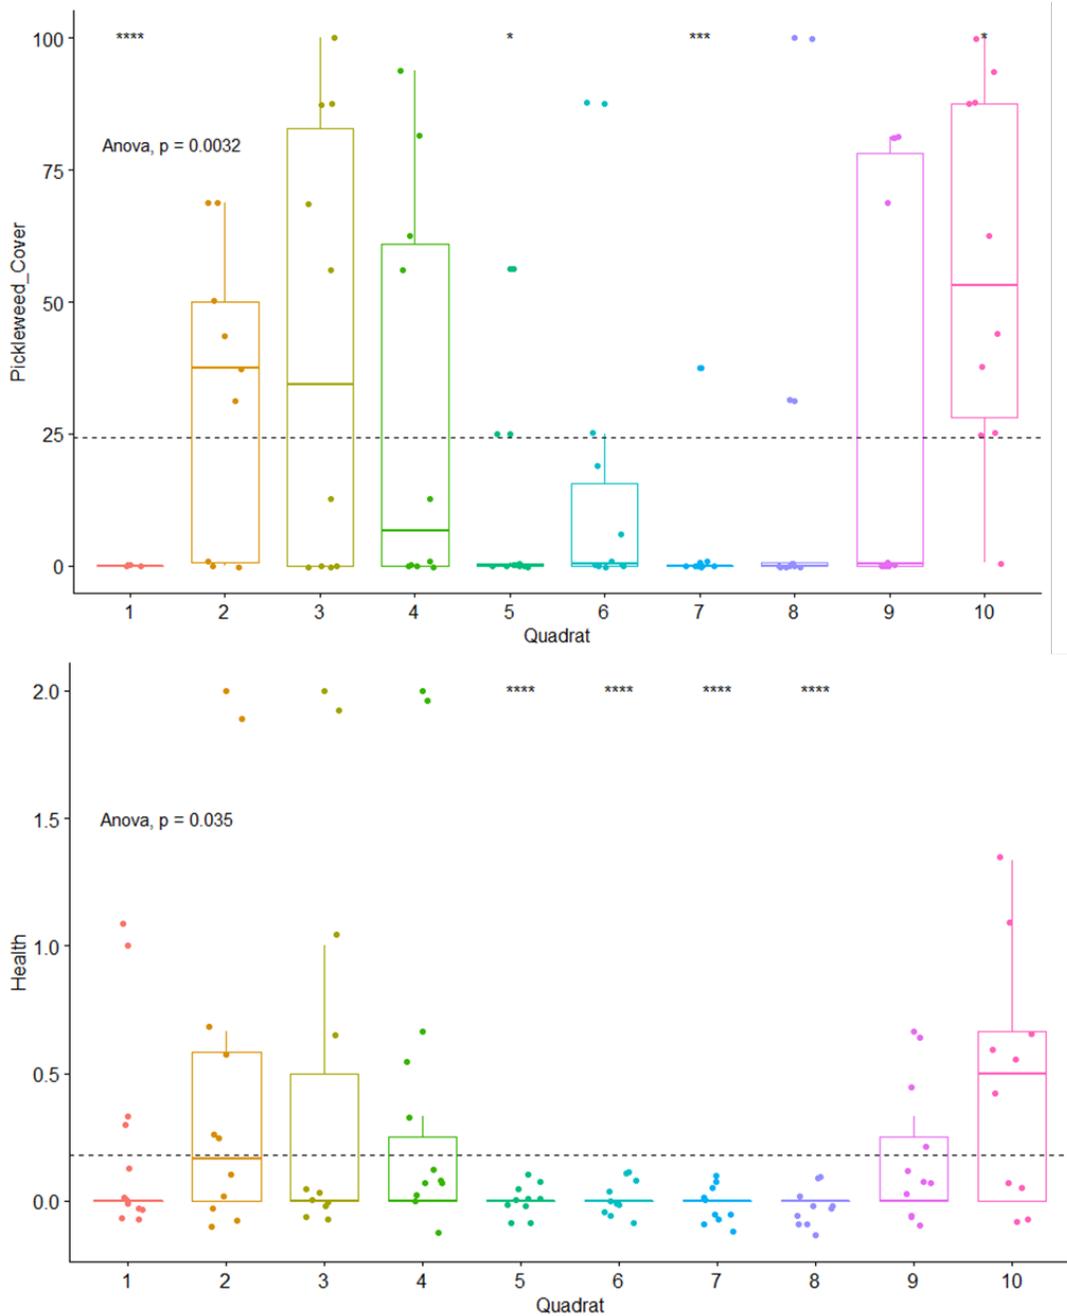
Fig. 12. Top: Percent cover of colonizing pickleweed averaged for each quadrat along the 10 quadrats in September 2020; quadrat 1 is at the upland boundary, and quadrat 10 is at the creek/channel boundary. Bottom: Average health of pickleweed transplanted to each of the same quadrats in Spring 2020. In both cases, quadrats 5-8 in the lowest elevations at the middle of the transects appear to have most stressful conditions, limiting colonization and health of transplants.

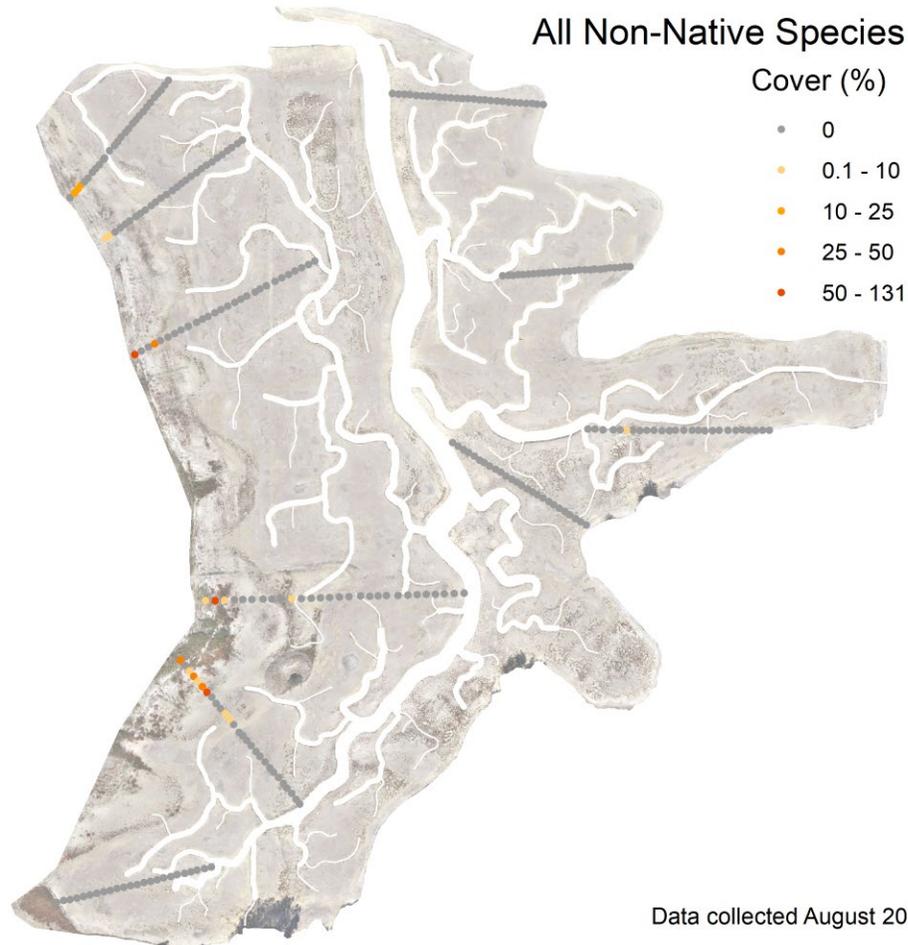
Fig. 13. Spatial variation in non-native species cover in August 2019 (marsh and upland non-natives combined). Non-natives are almost exclusively restricted to the western side of the site, where sediment was scraped and elevation is highest. Cover over 100 percent was observed at some quadrats due to canopy layering (see Percent Cover description under Detailed Monitoring Methods). Quadrats with existing vegetation are excluded.

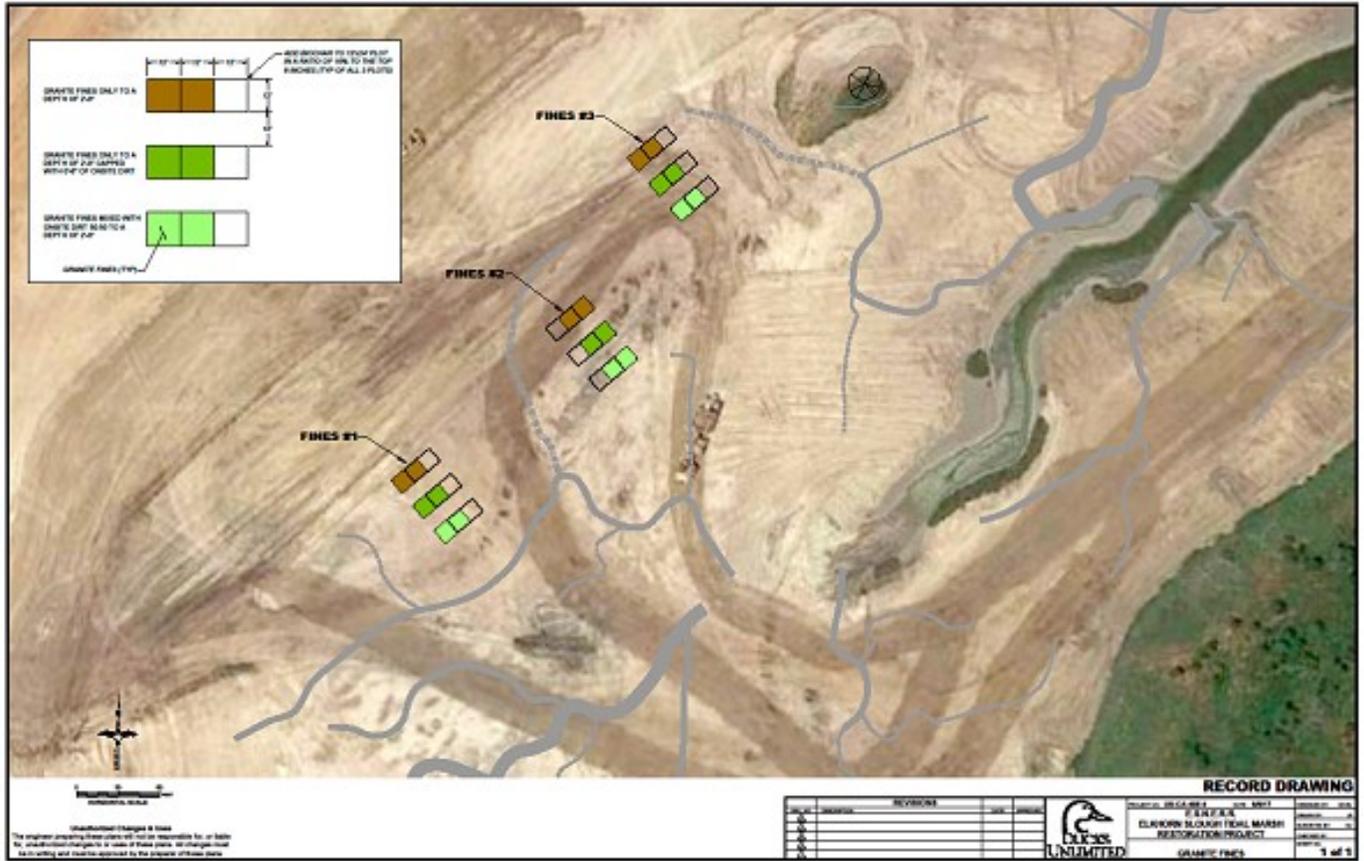
Fig. 15 Experimental design of granite fines and biochar use for restoration. Each replicate consists of three elevations each with three 12 x 12 ft squares at each elevation. One square was biochar only, one square was granite fines, and one square was both biochar and granite fines.

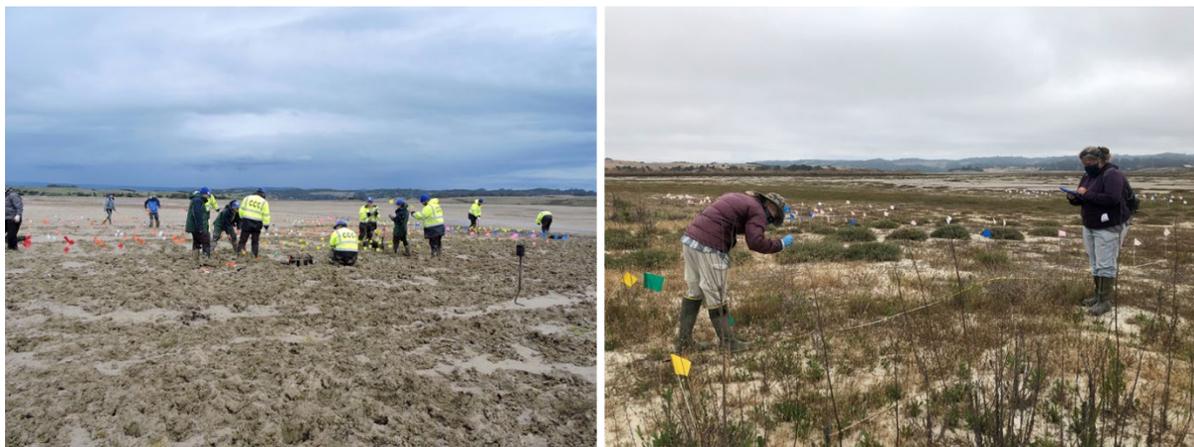
Fig. 25. (Left) initial conditions in the planting area showing bare landscape in January 2019; (Right) same area in July 2020 during percent cover point intercept surveys.

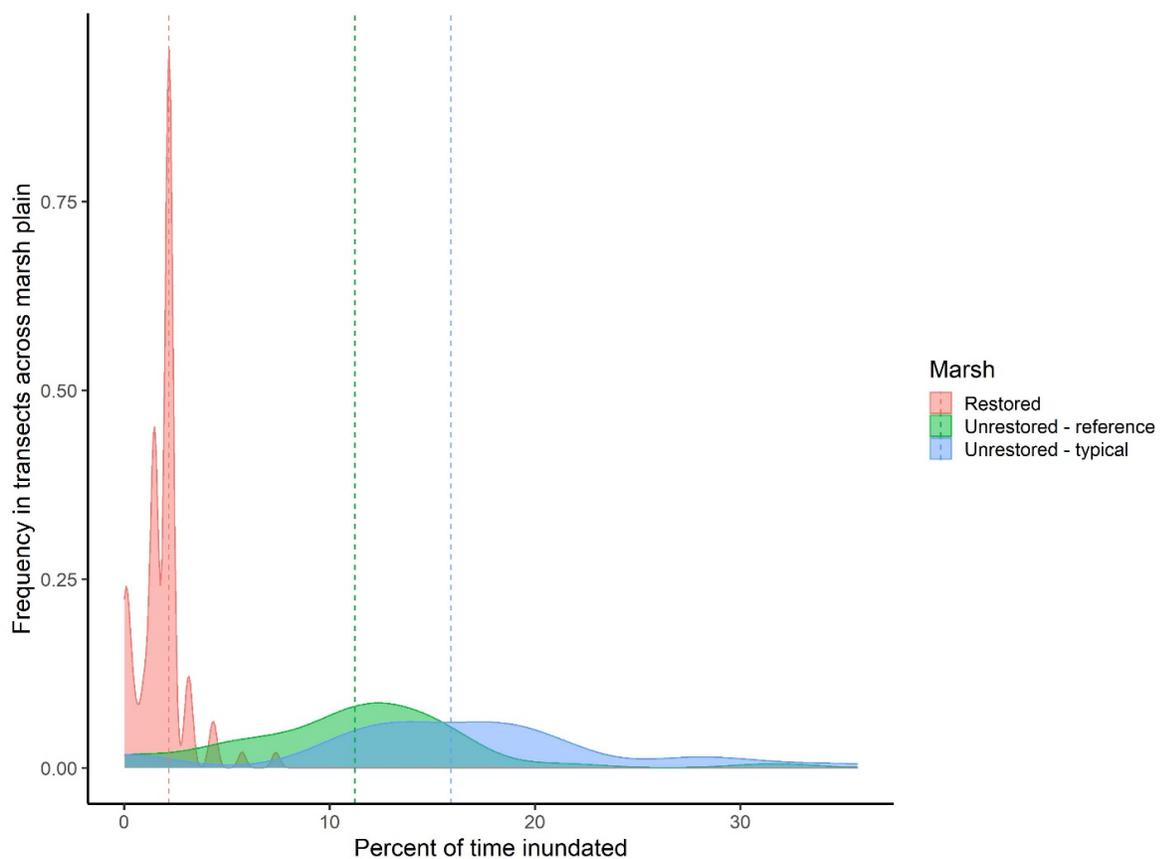
Fig. 34. Inundation of the marsh plain at Hester (100 quadrats), unrestored high reference marshes (40 quadrats), and unrestored typical low marshes (40 quadrats). Both figures are visualizations of the same data; the top panel focuses on comparison of the mean and variance and provides a statistical analysis, while the bottom panel shows the frequency of different inundation times across the marsh plain at the three types of marshes. It is clear that all of Hester marsh plain is inundated only infrequently, while unrestored marshes are inundated much more

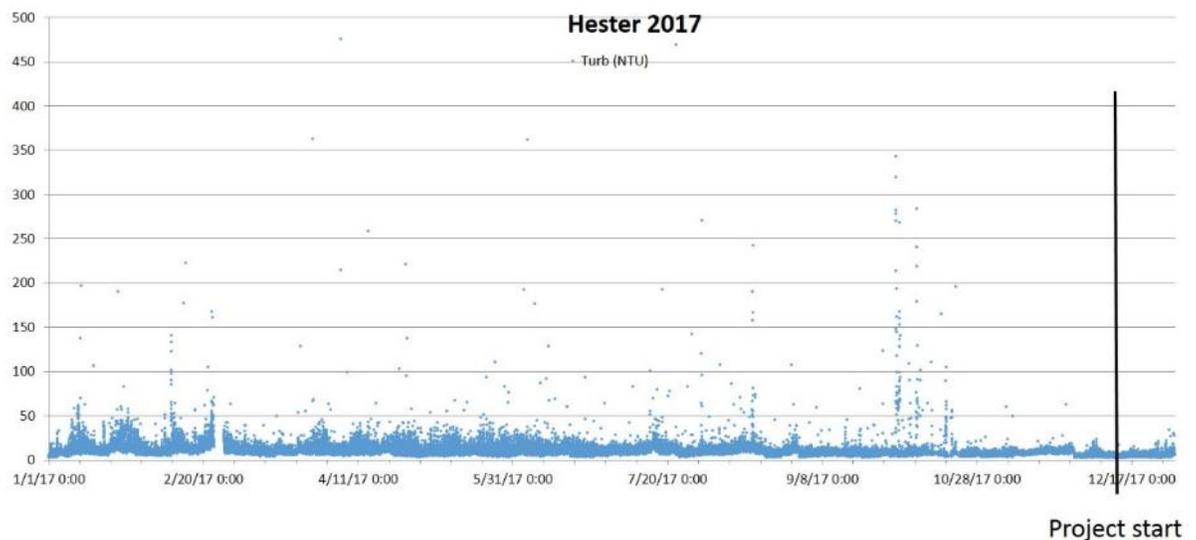
Fig. 41 Turbidity at Hester 1/1/17 to 12/31/17. Construction began 12/11/2017.

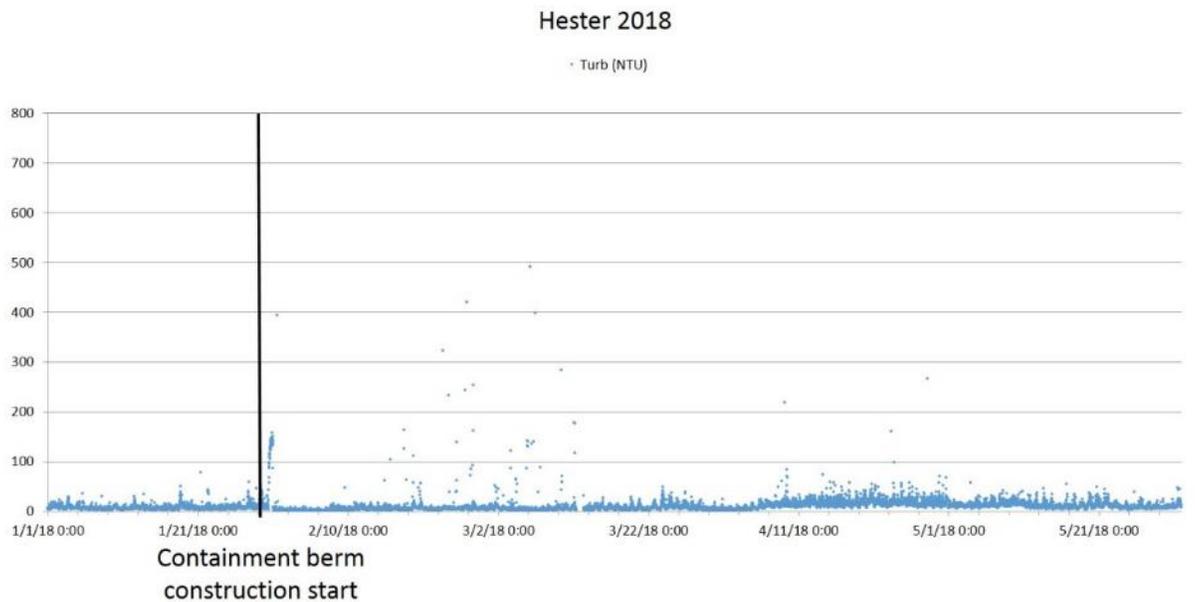
Fig. 43 Turbidity at Hester 1/1/2018 to 5/31/2018

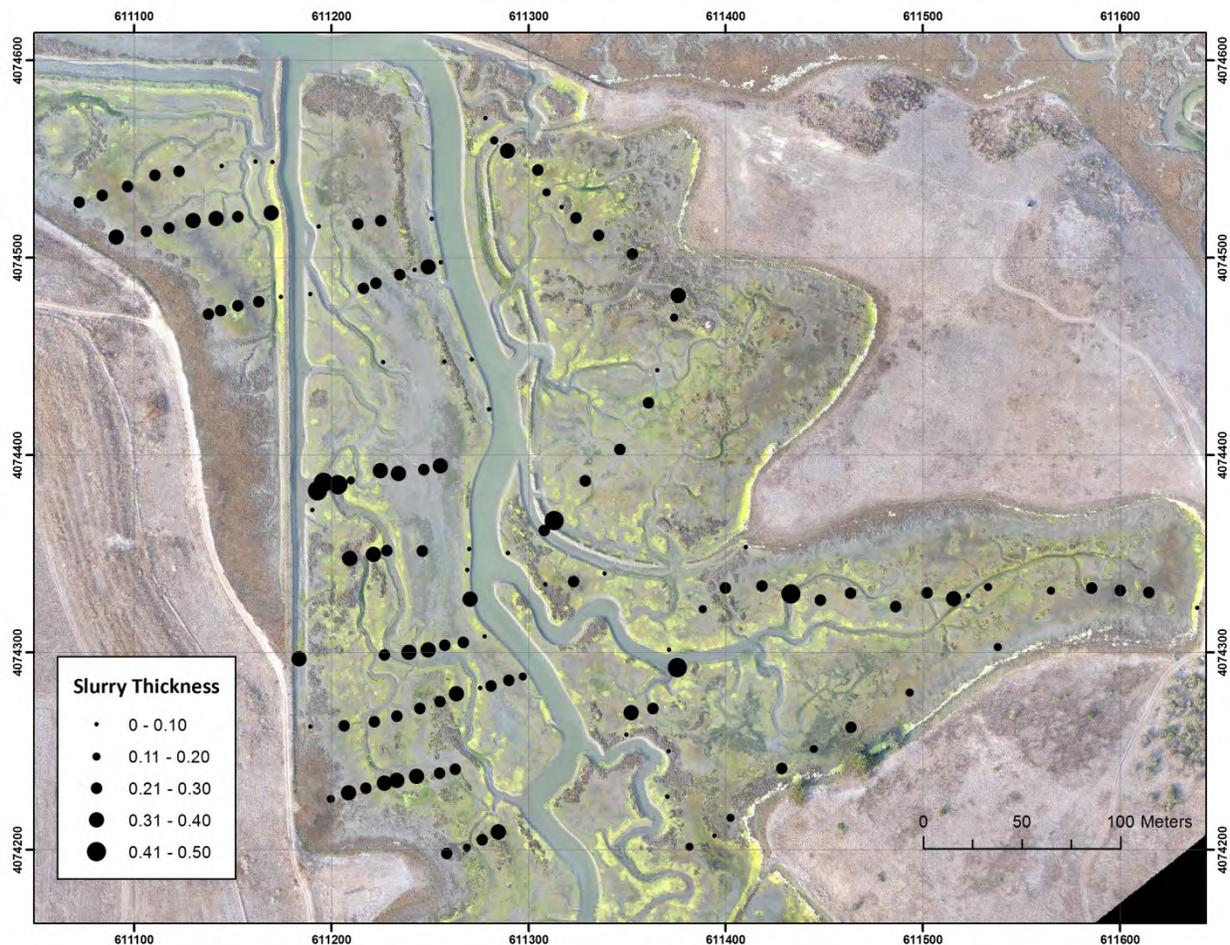
Figure 1 –Overview map of the MHM area and location of the 136 survey sites. The size of the circle at each site corresponds to the thickness of the 'slurry' layer

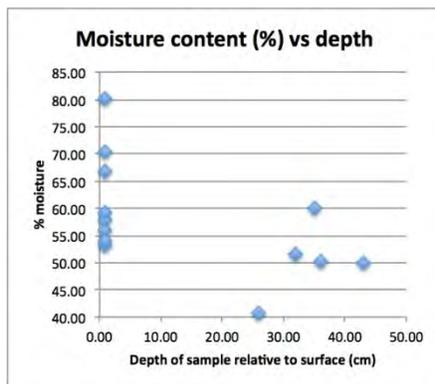
Figure 4 – The plot shows how the 'slurry' samples (0 cm) have higher moisture content than the samples from the 'plastic' layer (~25-45cm).
