Hester

Marsh

Restoration:

Annual report summarizing the changes in conditions at Hester marsh after implementation of a major restoration project – marsh creation via soil addition

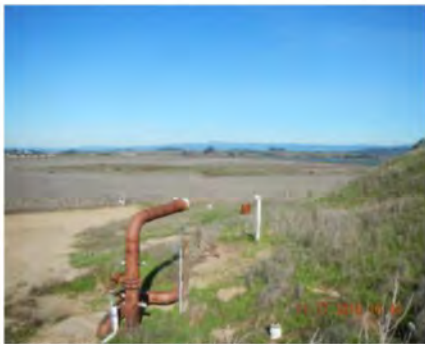
Figure 5. Pump that fills pond shown in Figure 4. In middle background is marsh to be restored, and on left above green marsh area is the storage area.

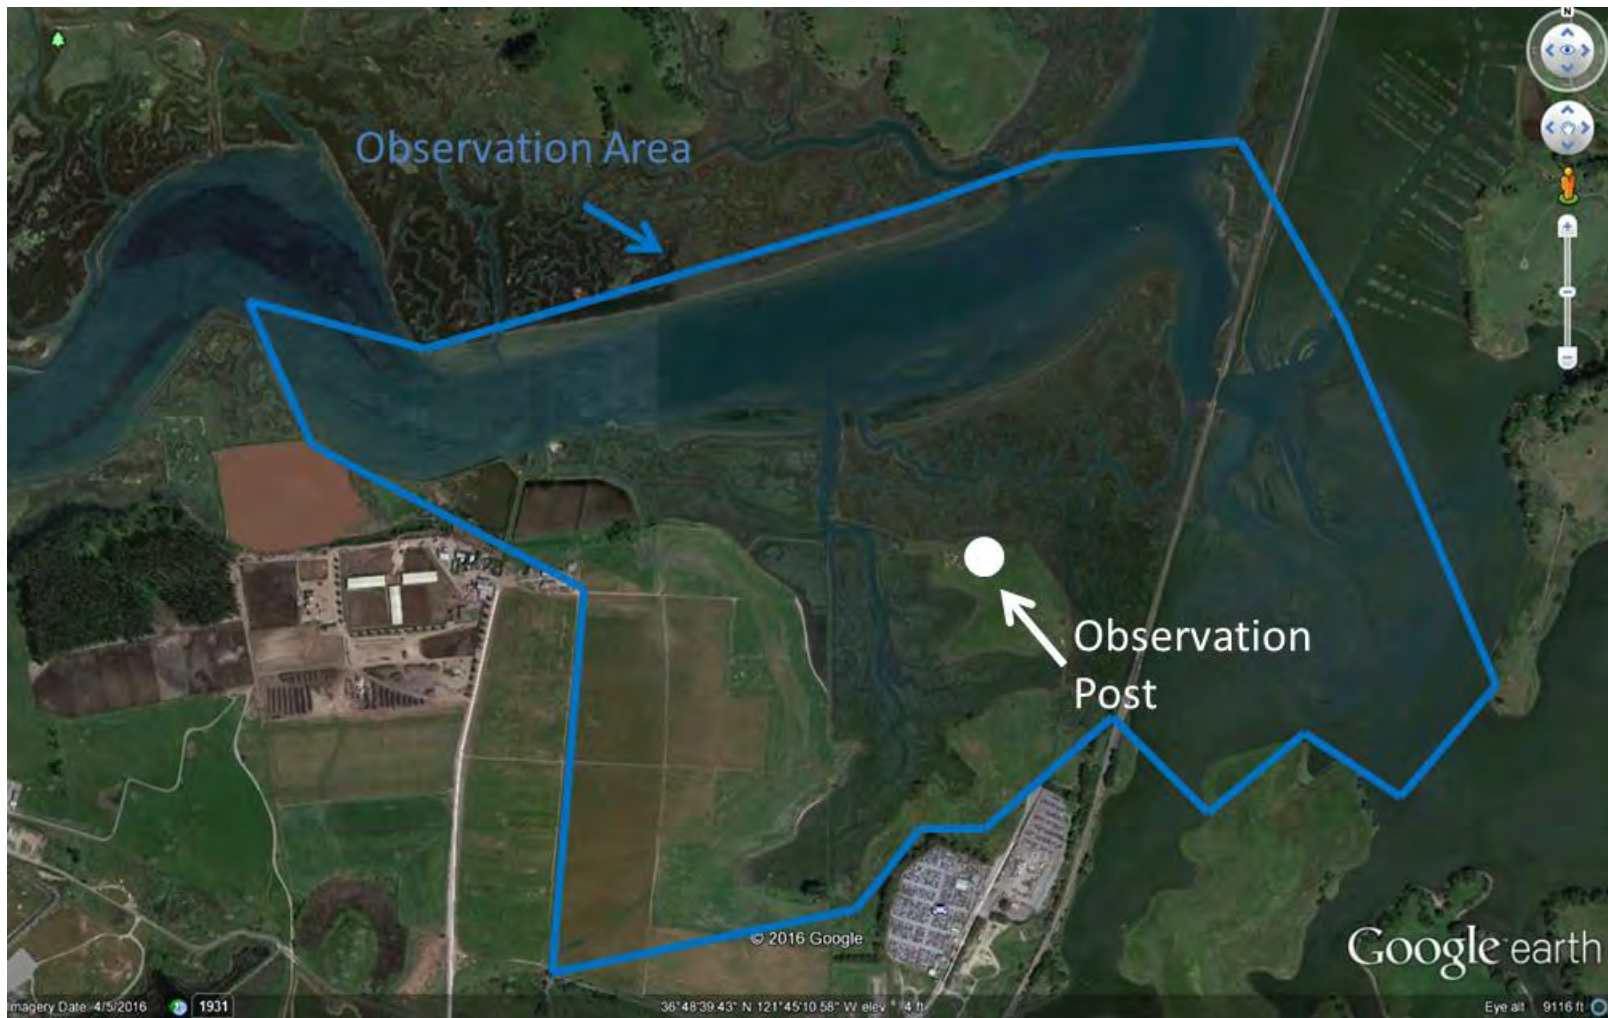
Figure 1. Observation post and observation area. Note: Some areas around the railroad tracks and within the healthy marsh just north of the post cannot be seen at low tides.

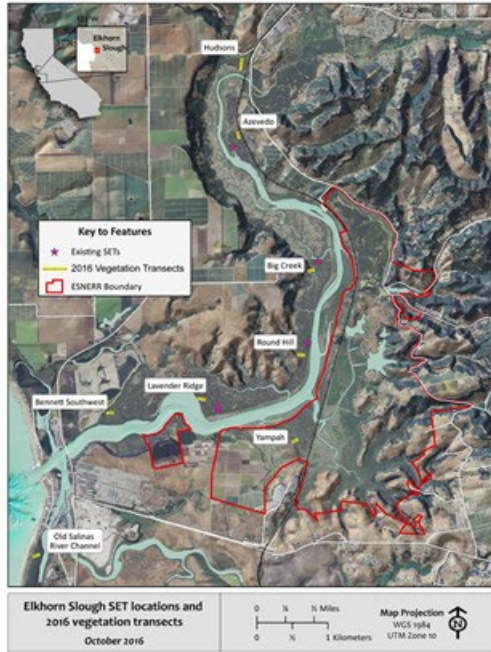
Fig. 10. Reference sites

Reference sites: We chose eight sites representing a range of conditions and locations across the Elkhorn Slough estuary, including high, healthy marshes and lower, degrading ones (Fig. 10). We did not sample the most degraded marshes in the system, which have already largely converted to mudflat, so our sampling provides a more positive assessment of marsh health than would have been obtained from random site locations taken across the entire historic marsh footprint. We sampled mostly in areas that have never been diked, because our primary interest is in understanding marsh loss that has occurred in undiked regions of the Slough. Most marshes on the Reserve were diked and drained and converted to agricultural uses. When tidal flow was returned following establishment of the Reserve, these areas were too low to support marshes and now are shallow mudflats. Yampah Marsh, which was never diked or drained, is the only one of our sites that is on the Reserve. The marshes we sampled are listed below, approximately in order from healthiest to most degraded, with a brief description. We expect Hester Marsh to be broadly similar to the first three sites, and to have greater percent cover, canopy height and marsh community diversity than the remaining sites.

We used the same transects as described above in section 1.3 to evaluate inundation at eight unrestored natural marshes shown in Fig. 10. Four of these are low marshes typical for Elkhorn Slough (Big Creek, Round Hill, Yampah, Bennett Southwest), while four are the highest marshes in the system (Hudson, Azevedo, Lavender Ridge, Old Salinas River Channel), which serve as references of healthy marshes, at least at the upper ends of the transects. There are 10 quadrats per transect evenly spaced from the landward to seaward boundary of the marsh. Elevations were measured for each quadrat in 2016. We assessed elevation at the ten transects (each with 10 quadrats) at Hester Phase I as described above in section 1.3

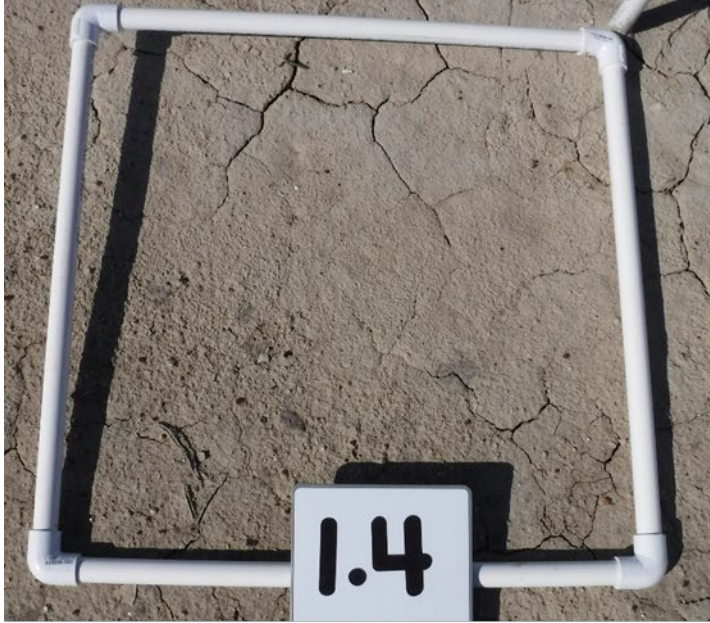
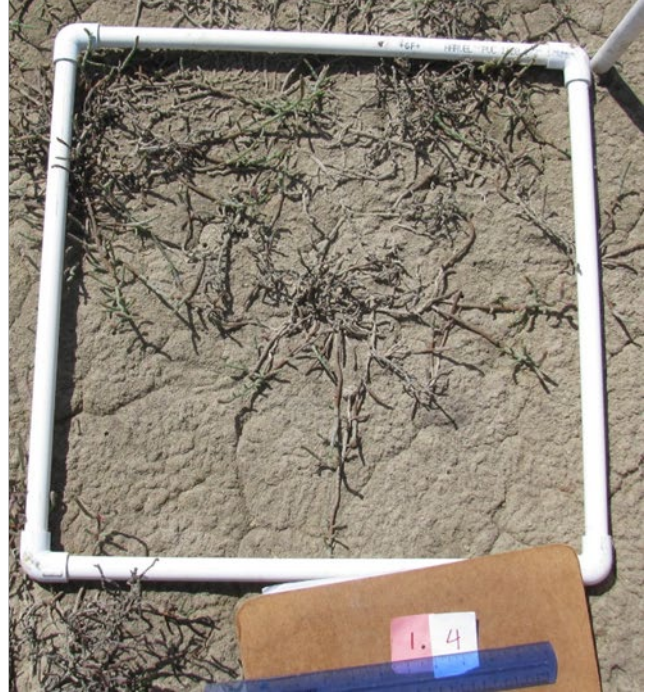
Fig. 11. Pickleweed growth between summer 2019 (left) and summer 2020 (right) at a representative quadrat on a monitoring transect.

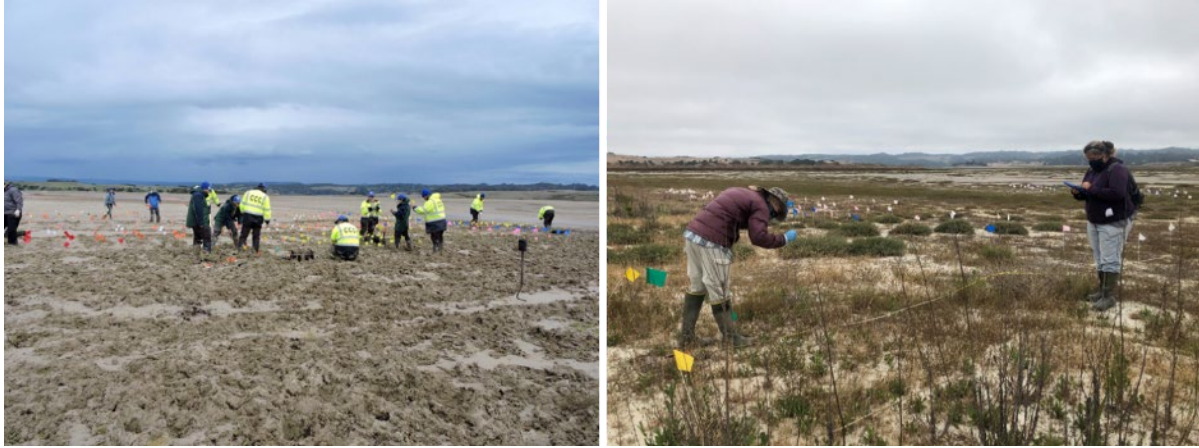
Fig. 27. (Left) initial conditions in the planting area showing bare landscape in January 2019; (Right) same area in July 2020 during percent cover point intercept surveys.

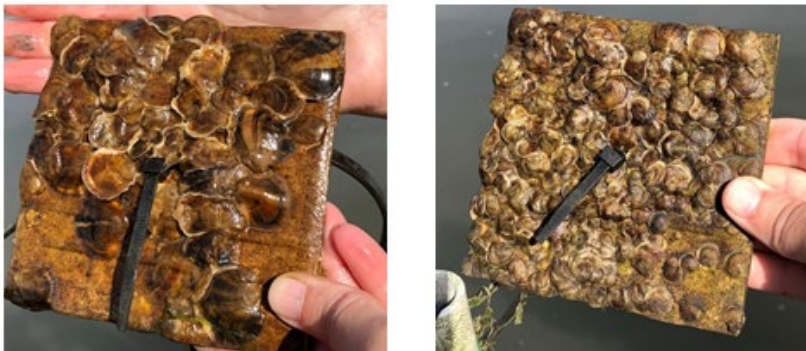
Fig. 34. Growth rate (top graph) and survival (bottom graph) of hatchery-raised oysters restored in December 2021, as monitored 15 weeks later. Deep = approximately MLLW, Shallow = approximately 1.5 ft. above MLLW. Photos at bottom show size difference of oysters in deep (left) vs. shallow (right) water.

About 7000 juveniles were deployed in December 2021. Initial monitoring in March 2022 revealed excellent survival and growth. Both were higher in deeper water (Fig. 34).

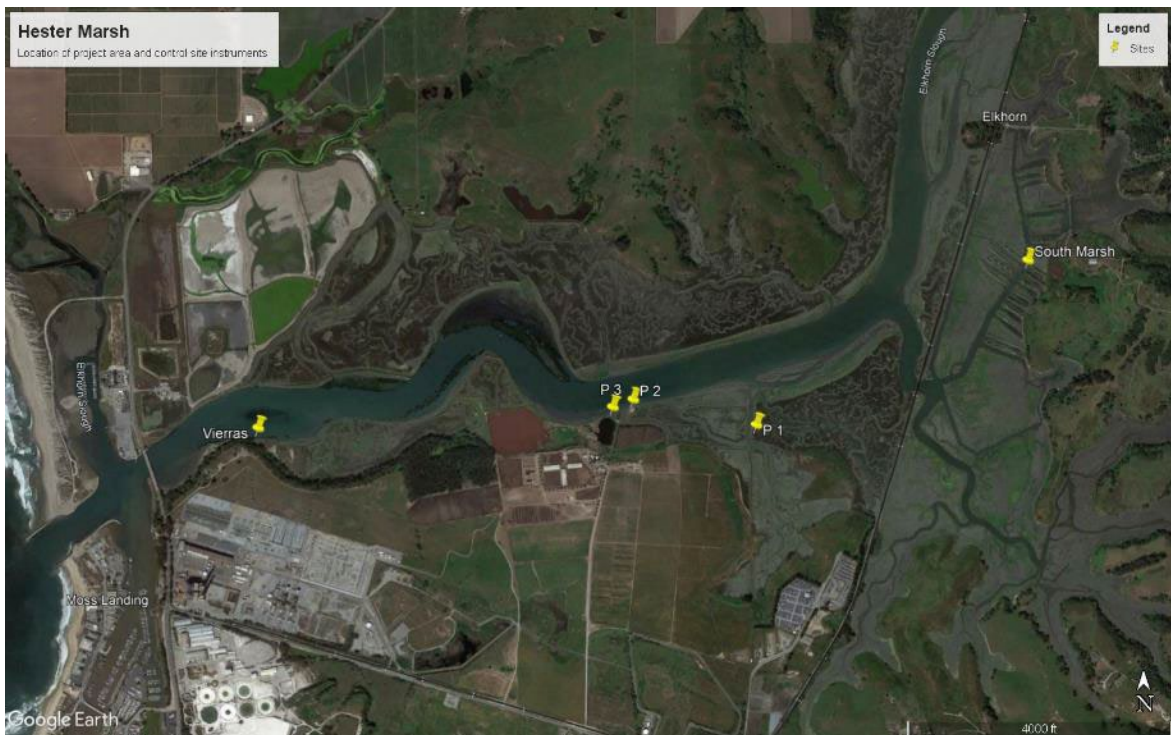
Fig. 40. Locations of water quality sondes at the restoration site (P1, P2, P3) and control sites (South Marsh, Vierras).

For all project phases I-III, we monitored water quality at a site in, or near, the project area and at one control site (Vierras) (Fig. 40). The Vierras control site is located near the mouth of the estuary and remained the same for all three phases. Site locations for individual phases were: Phase I, one site directly adjacent to the project site (elkmhwq). Phase II, one site directly adjacent to the project site (elkmcwq). Phase III, one site within the project site (elkhpwq) before restoration. We also used data from nearby sites monitored for the reserve (South Marsh) (Fig. 40), for occasional comparisons to the project site. We monitored water quality 5 years before, during, and 5 years after site restoration, whenever possible due to weather and construction activity constraints. We deployed YSI data loggers and monitored the following water quality parameters near the project site: temperature, salinity, turbidity, pH, dissolved oxygen.

Fig. 44. Turbidity data from Hester project site (1/1/2017 to 10/4/2020) and the Vierra control site (1/1/2017 to 12/31/2020). Due to Phase II construction, the sonde had to be moved from Hester site P1 (Fig. 40) to site P2 in October 2020. Before construction of Phase I, Hester turbidity average was higher and more variable than turbidity at Vierra. After construction of Phase I, Hester turbidity decreased and was similar to turbidity at Vierra, the control site.

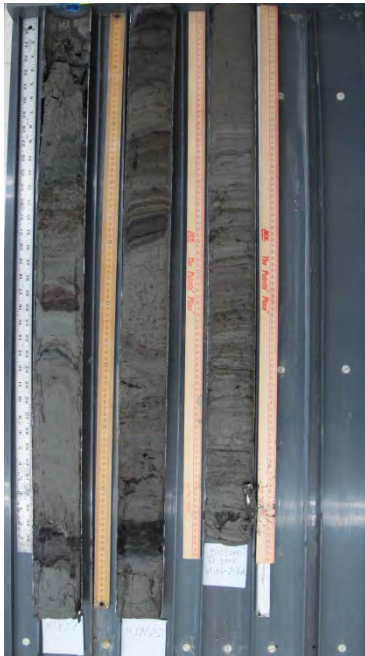
Figure 2 – Core table photograph showing the lithologic characteristics of the consolidated to over-consolidated sediments at Minhoto including alternations between laminated and homogenous intervals.

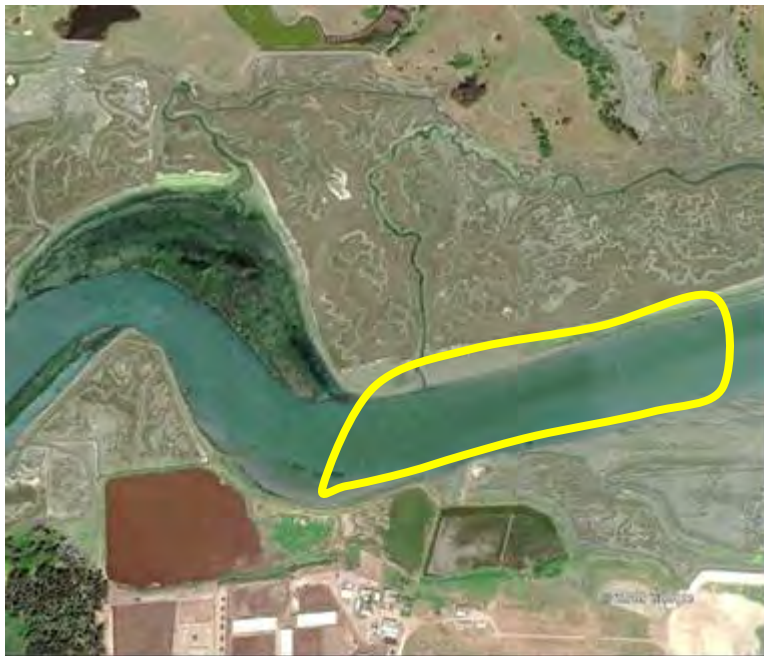
Position yourself by the building overlooking the slough. Count otters west of your location to seal bound, and then north to the Yampah boundary. Also observe any otters in Rubis creek, directly across from your location.

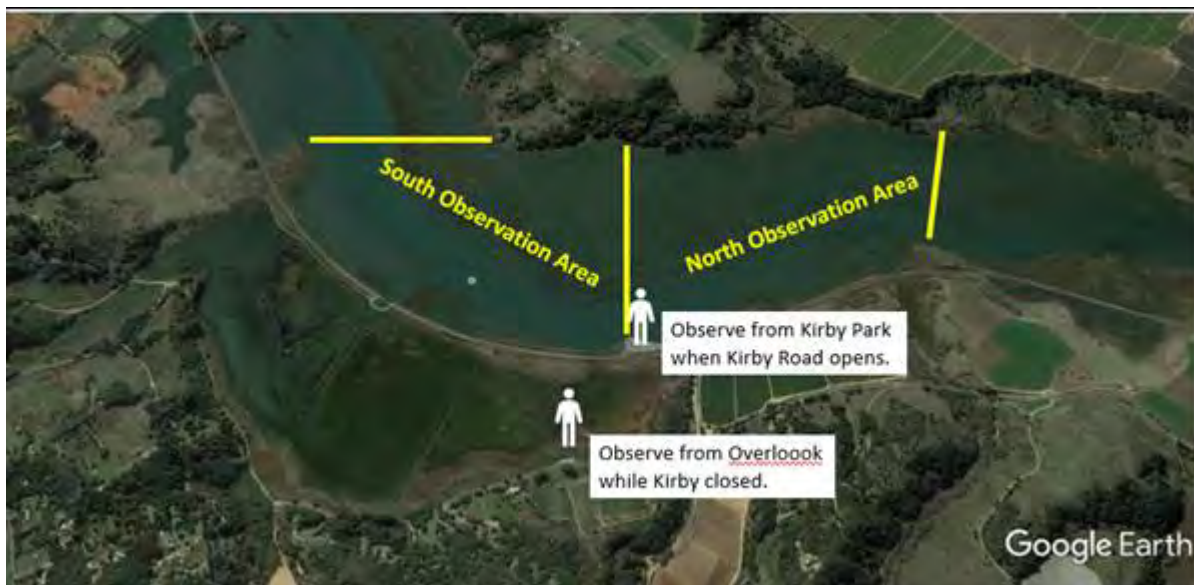
The Kirby Park dock divides the observation areas into north and south. See boundaries on the following image.

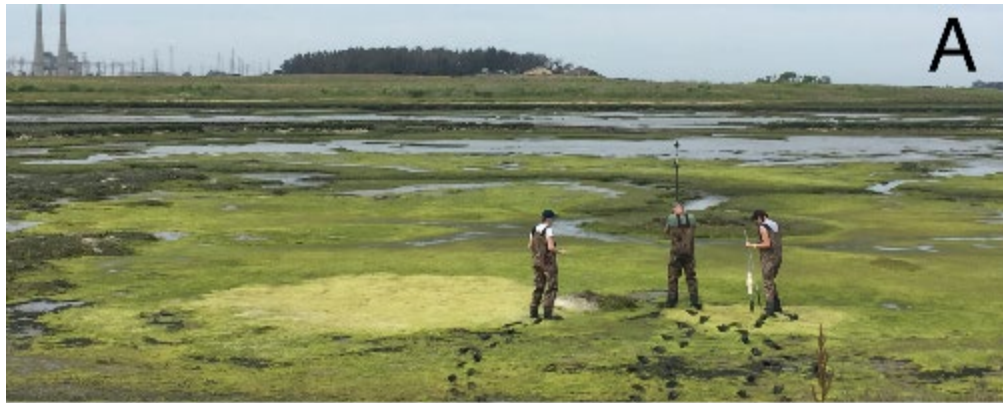
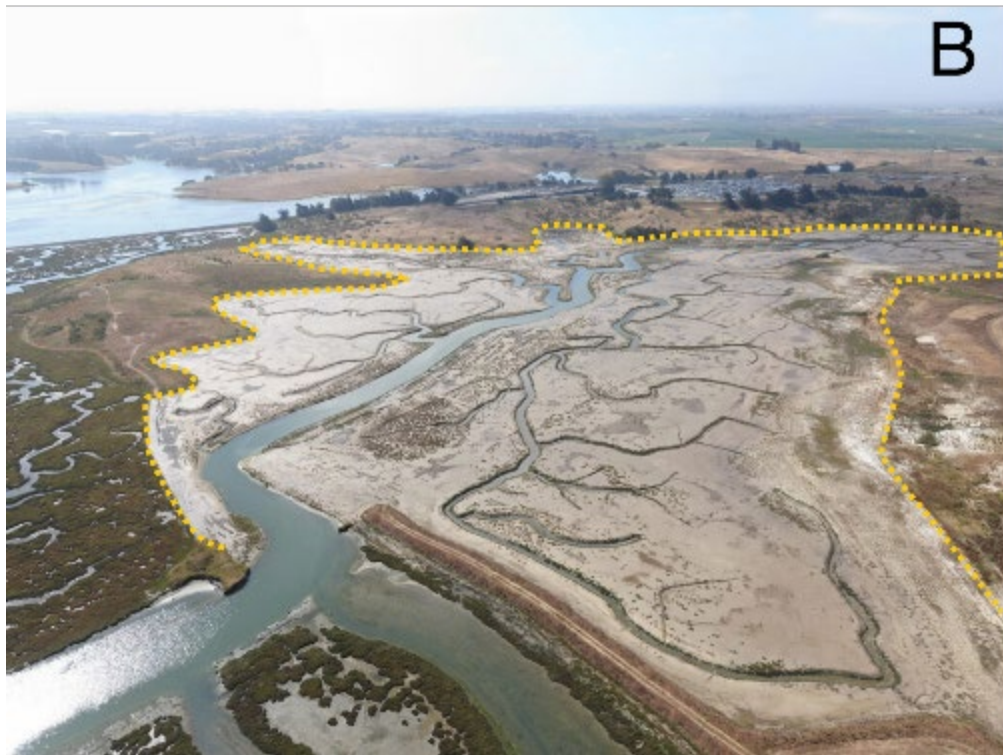
Figure 3 - Typical elevational profiles for habitat distribution at Elkhorn Slough marshes.

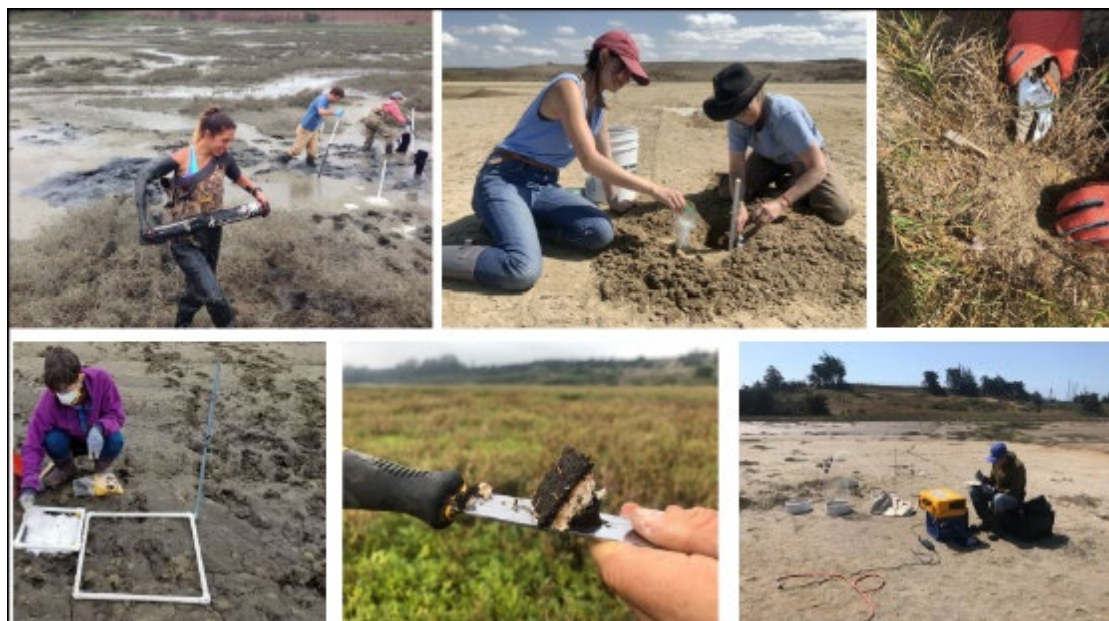
Fig 4. Field methods. A - sediment sampling via coring at Hester prior to restoration, B - sediment sampling at Hester immediately after construction was completed by collection from auger holes, C - location where above-ground biomass was harvested with clippers, D - pouring feldspar marker horizons at Hester immediately following construction, E - sediment accretion on feldspar “brownie” at reference marsh site, F - monitoring greenhouse gas emissions at Hester 3 yrs after construction *Draft [here](#) - please re-arrange or replace with your preferred photos and Kerstin can pretty up and finalize*

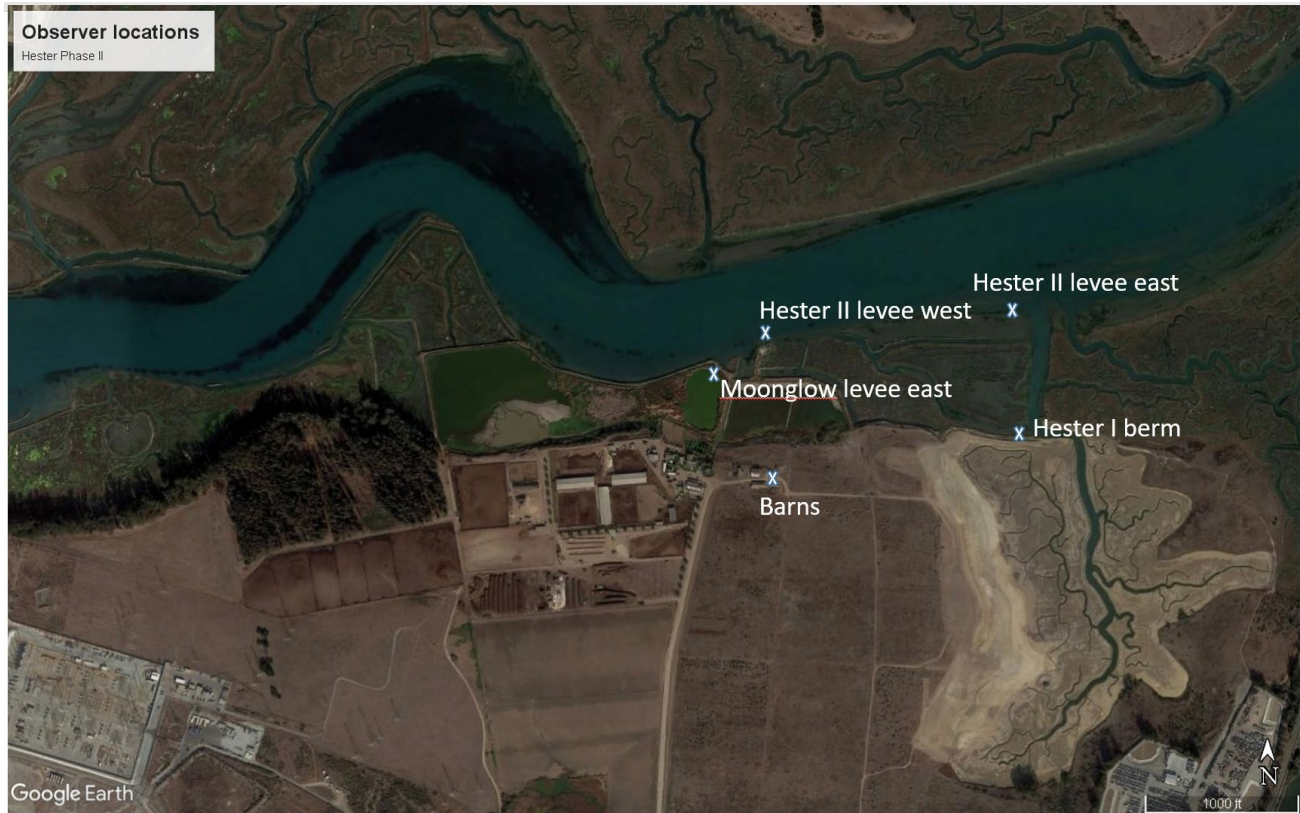
Figure 2. Observation posts.

Note: Some areas within the marshes cannot be seen at low tides which necessitated observers moving throughout the project area.
